ICE ACCUMULATION IN NOFROST MODULE/ TO HIGH TEMPERATURE

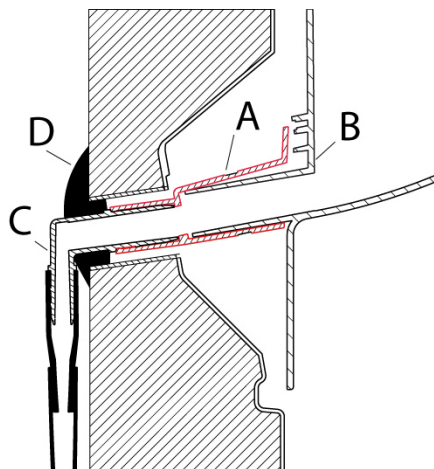
When reassembling the module, check that the rubber sleeve at the outlet (A) is not loose from the module (B). Check also that the plastic part of the draining hose (C) is pressed against the module and fits into the rubber draining sleeve. Isolate carefully with sealing compound (D) (see picture).
