ALARM EF0 (EF3) IN APPLIANCES HEC ARCHED

EN	Publication no.	599 71 70-63	Rev. 00	03/2009	dmm
----	-----------------	---------------------	---------	---------	-----

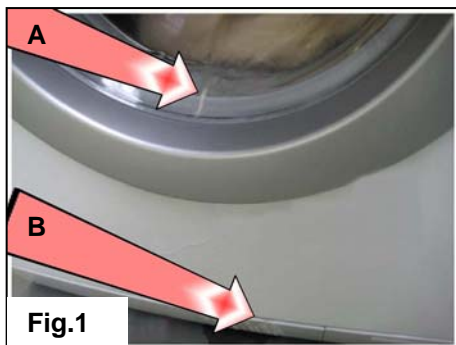
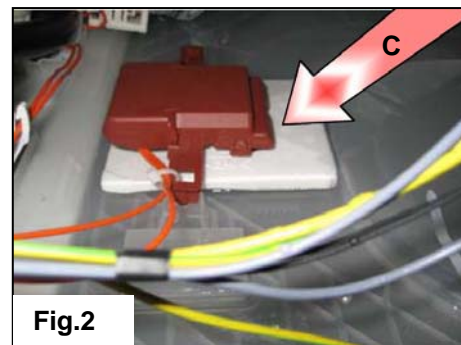
In some cases it may happen that some small pieces of clothes infiltrate between the door and the rubber bellow (fig.1 A). This causes a small water leakage, which through the front panel/plinth junction (fig.1 B), flows inside the appliance, thus switching on the Aqua Control sensor (fig.2 C) and generating alarm EF0/EF3.

Incline the washing machine of about 10 cm to spill the water, so that the sensor can operate normally again.
