Publ.-Nr.:
599 717 587
685
EN

Built-in hob

„PROMISE“

DGS-TDS-N
Edition: 04.09

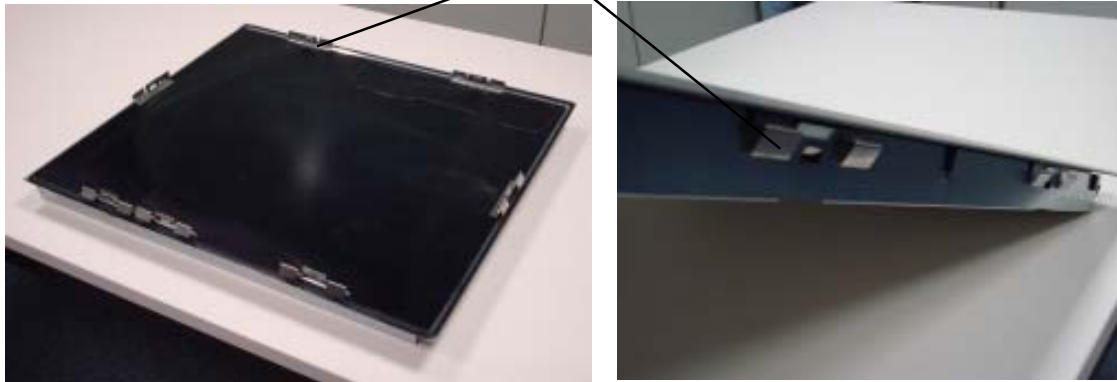
Retention springs

The main feature of this top series is the retention springs which are directly adhered to the ceramic glass, with which the ceramic glass and the top trough are held together (snap-fixed). An additional feature is the seal which is adhered to the ceramic glass support for the input electronic of autark hobs and the top frame which is adhered to the ceramic glass.

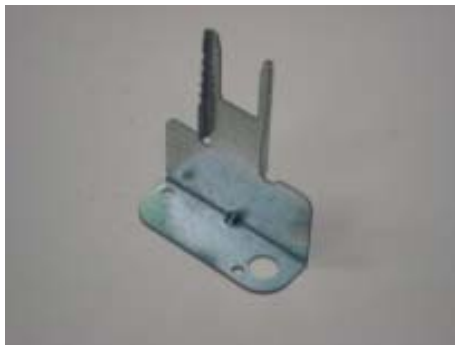
Dismantling requires the unlocking tool, SP No.: 387 795 800/3.

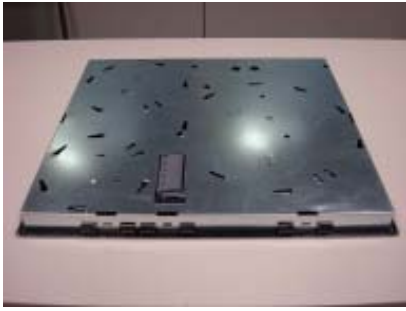
- Image 1 Remove the hob and place it on the ceramic glass after turning it over.
- Image 2 Use the unlocking tool, SP No. 387 795 800/3 for the next step.

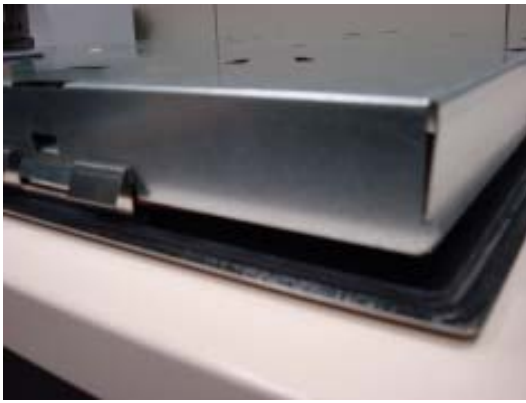
- Image 8 All of the retentions springs have been loosened (disengaged). The top trough has evenly lifted itself off the ceramic glass by approx. 5mm.
- Images 9 -12 Turn the hob over and place it on the top trough without "re-engaging" the retention springs.

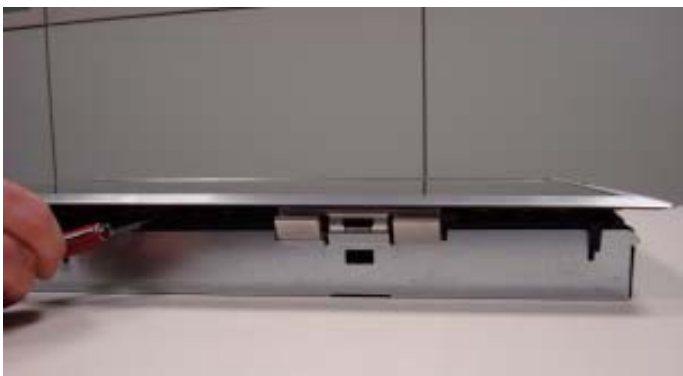
- Image 13/14 The illustration shows the loosened retention spring and the ceramic glass/top trough clearance. With autark hobs, care is to be taken to ensure that the adhered seal is cleanly released from the input electronic support and is not damaged when lifting the ceramic glass. Remove adhesion with a knife if necessary.

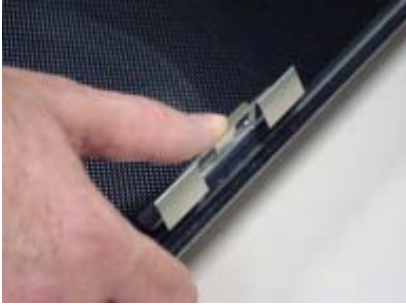
- Image 15 Before assembling the hob, ensure that the retention springs are positioned vertically. In order to ensure a firm engagement, it might be necessary to slightly press the centre of the spring in the direction of the appliance exterior.

CAUTION! If the adhesion of just one retention spring should be damaged (e.g. cracked), the replacement of the ceramic glass is mandatory!

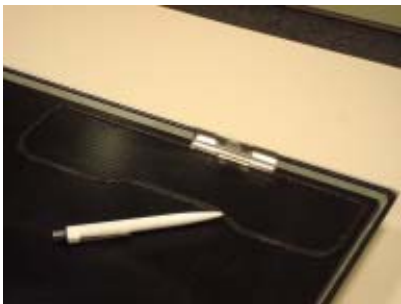
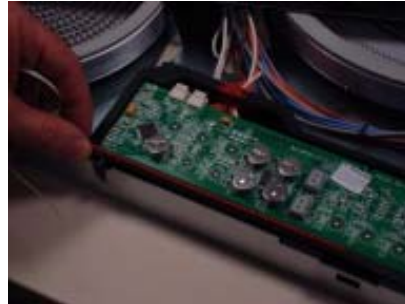
- Images 16-18 Before assembling the hob, the seal, ceramic glass/support of the input electronic should be inspected for signs of damage. In case of damage, the adhered seal has to be removed from the ceramic glass and a new seal, SP No.: 387 902 210/5 attached to the support of the input electronic (fig.17 / 18).

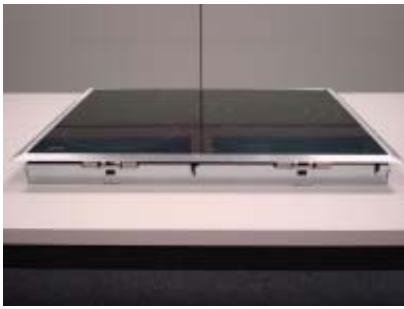
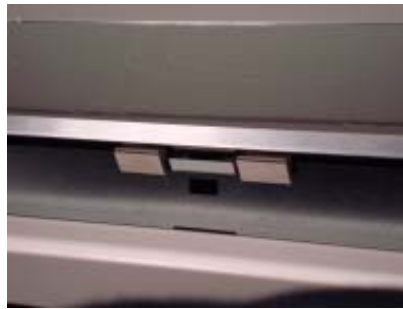
- Images 20/ 21 An even placing of the ceramic glass on the top trough with a subsequent inspection of each of the retention springs.
- Image 22 Application of even pressure to the ceramic glass until one hears the retention springs engaging.

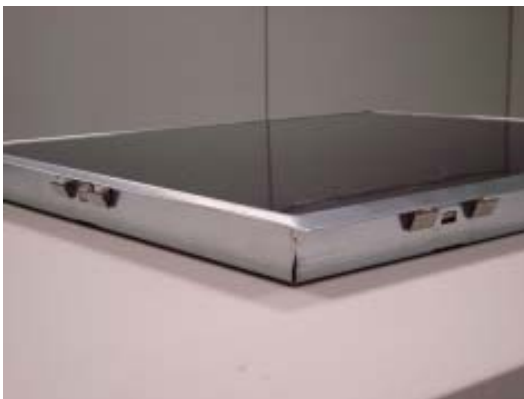
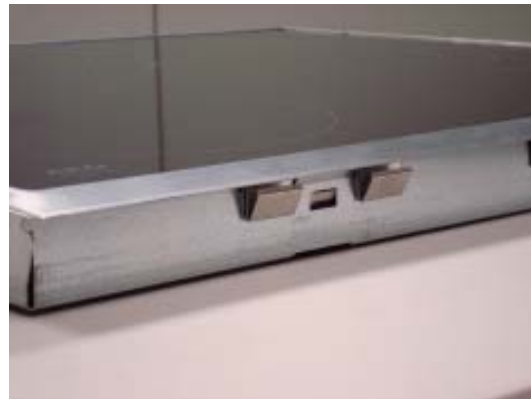
- Images 23 / 24 Final inspection of the retention springs for a secure engaging and secure hold.
