REMOVING THE EARTHING PIN FROM THE WELDED TUB CASING ASSEMBLY

From Serial Number 923 xxxxx, the earthing pin has been removed from all welded tub assemblies. Consequently:

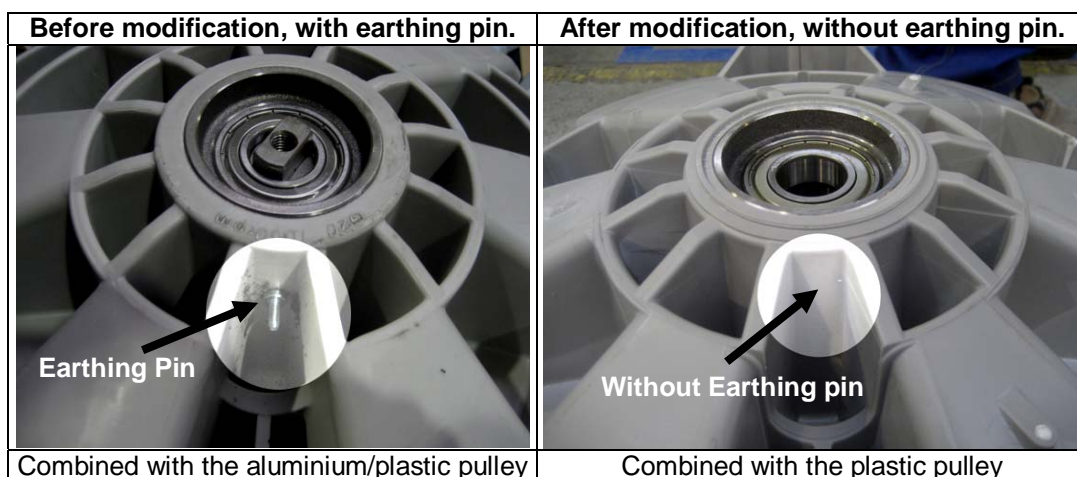
- the relevant wiring is removed and the plastic pulley is used.

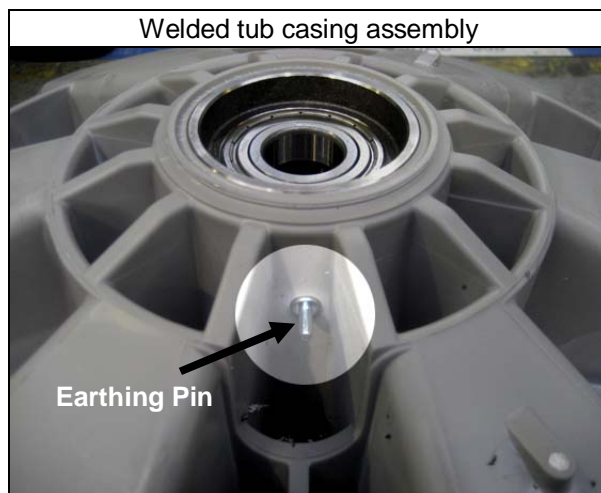
The welded tub casing assembly, complete with rear casing fitted with earthing pin, is supplied as a spare part and can be used on all appliances, as shown in the diagram provided in the table in the paragraph entitled "service information".

- **PULLEY**
If the appliance is fitted with a welded tub assembly that has a rear casing without earthing pin.

**ONLY PLASTIC PULLEYS CAN BE USED
 AND USE OF ALUMINIUM PULLEYS IS STRICTLY PROHIBITED.**

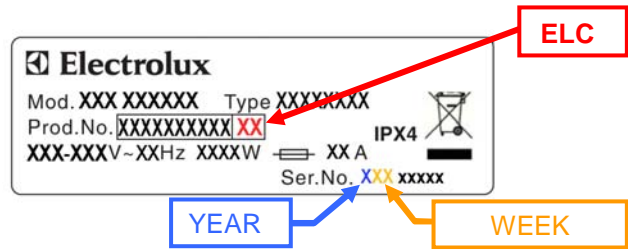
SERIAL NUMBER

ELC – last two figures after the PNC
YEAR last figure of the year of production
WEEK of production
