**WASHING MACHINE WITH STEAM GENERATOR**

EN	Publication number	<b>599 72 94-50</b>	Rev. 00	04/2010	dmm
----	--------------------	---------------------	---------	---------	-----

## SERVICE INFORMATION

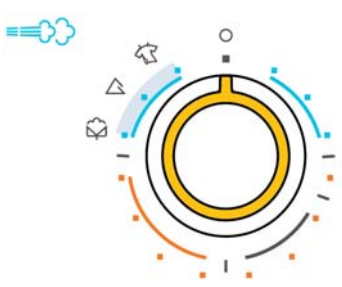
PROGRAMMES		PROGRAMME SELECTOR
For cotton (de-creasing)

For synthetics (de-creasing)

refresh (eliminates smells)

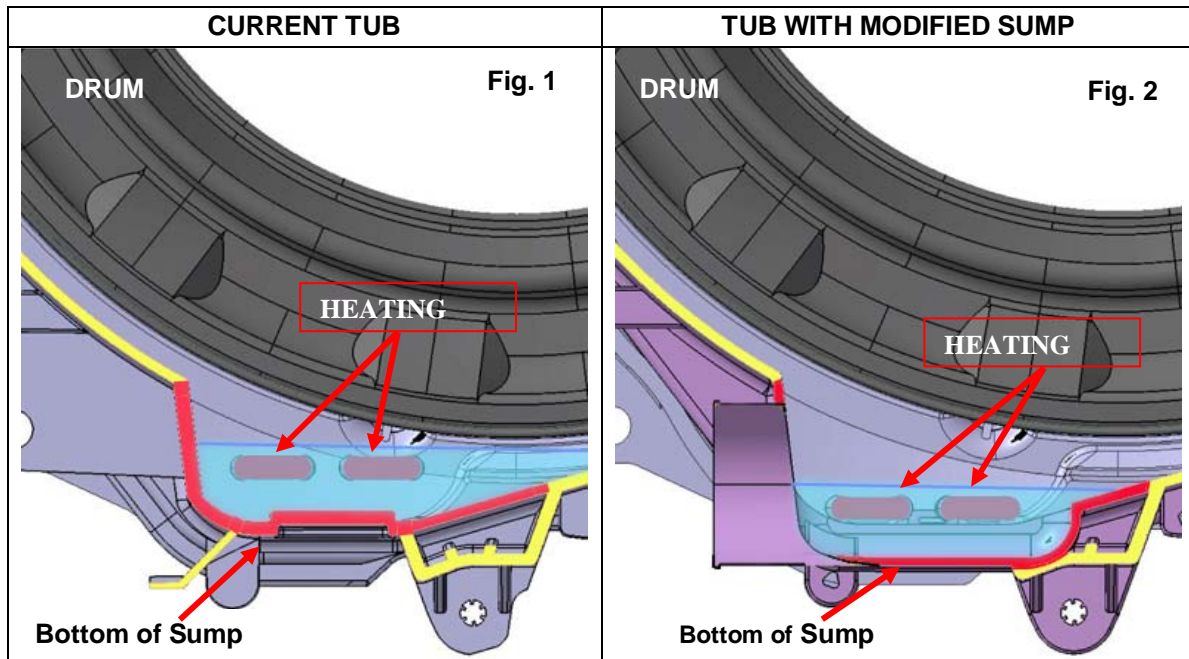
As can be seen from fig. 1, in the present welded unit assembly the position of the heating element is too close to the drum, and the amount of water necessary to submerge it might result in water entering the drum during movement, with the risk of wetting the washing.

Fig. 2 shows the changes made to the welded unit assembly to generate steam: the bottom of the sump has been lowered and the position of the heating element likewise, so that the amount of water necessary to generate steam does not come into contact with the drum. To the side of the sump is the welded unit assembly drain, unlike the other versions where it is located at the bottom of the tub.

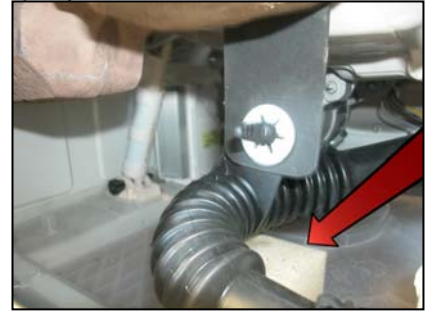
- Problems with drain

In the event of any problems with the drain, check that the strap supporting the drain pipe is not broken, or that the sponge (indicated by the arrow) is not worn, because if the former is broken and the latter worn the level of the pipe will drop; this will result in an air lock inside the pipe and therefore inefficient drainage.
