WHISTLING NOISE NEAR TOP OF MAIN DOOR

Consumer reports air leakage or whistling noise near top of main door. Problem is caused by gap between door and gasket. Problem can occur in AEG One Tumble Dryers with transparent door and serial number up to 650xxxxx.

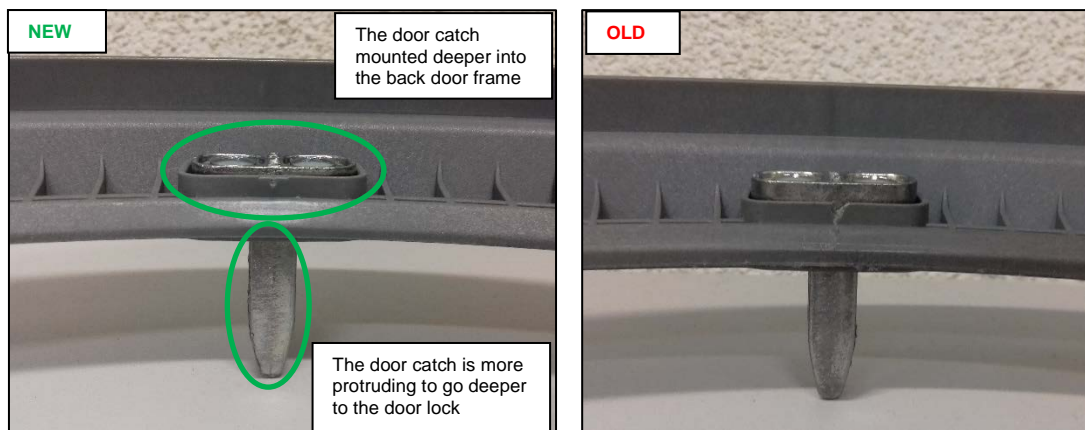
New back door frame let the door catch go deeper to the door lock while door closed. This should solve the problem with "self-opening" door after using new bigger gasket. See picture below please.

Replace door gasket and door pestle as well as back door frame.

New door gasket is bigger and adheres better to door surface.

New door pestle is longer and reduces possibility of drying cycle interruption.

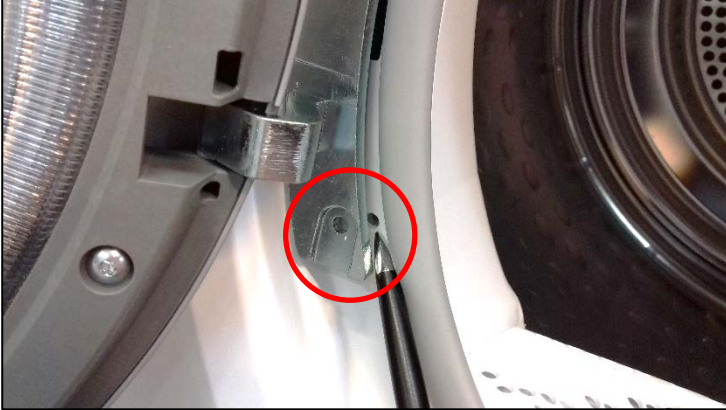
If the solution above still does not solve the whistling noise problem, use the additional washer between the door hinge and the air duct at the lower screw fixing door hinge. See indication below please.

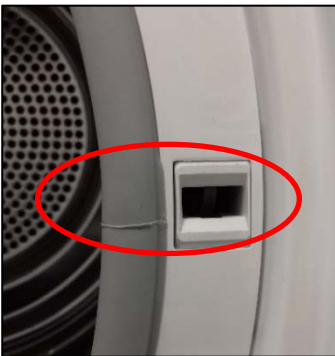
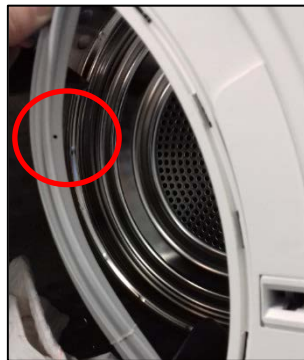
1. Before using new door gasket make sure that the gasket does not have some local shape changes (bends or dents). This can be caused by packing the gasket in too small package, which can change its normal shape. The gasket with such defect cannot be used as a spare part.
2. While the gasket installation its joint need to be located at the door lock. In this position the venting hole of the gasket is located in the area where the gasket is slightly less compressed by the door - it allows the gasket empty the air. Other gasket hole position may not let the air go out easily from the gasket which may limit the gasket's squeezability. See pictures below please.

3. Make sure that the vent hole in the gasket is open/free of contamination
4. Instruct consumer to close the door firmly. New gasket is bigger and can cause door to open during drying cycle. This problem should disappear after several drying cycles. It is also recommended that gasket after installation should remain in the door closed position for around 24 hours to make the gasket slightly reshaped / adopted
