Tub - door gasket deformation or damage. Upper basket rail collision with tub – door gasket.

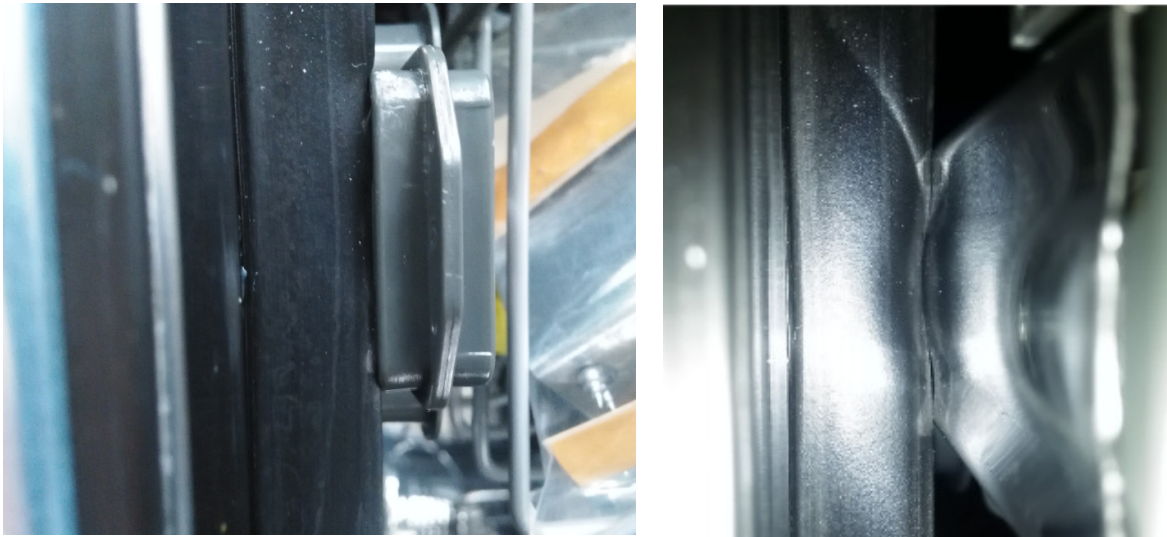
Upper basket rail collides with door – tub gasket. Gasket deforms or is damaged. Gasket can get detached from tub. Problem can occur in all Domodossola dishwashers with serial number up to 702xxxxx.

Rail collision with gasket.

Change upper basket rails and tub–door gasket. New upper basket rail has improved shape to avoid gasket damage.

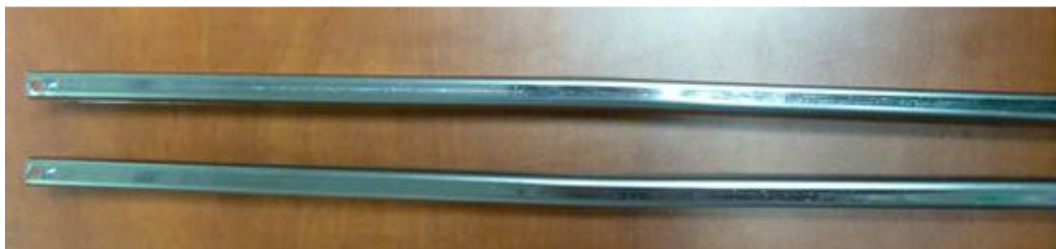
New rails.
