## OVERHEATING IN PUZZLE CEILING COOKER HOODS.

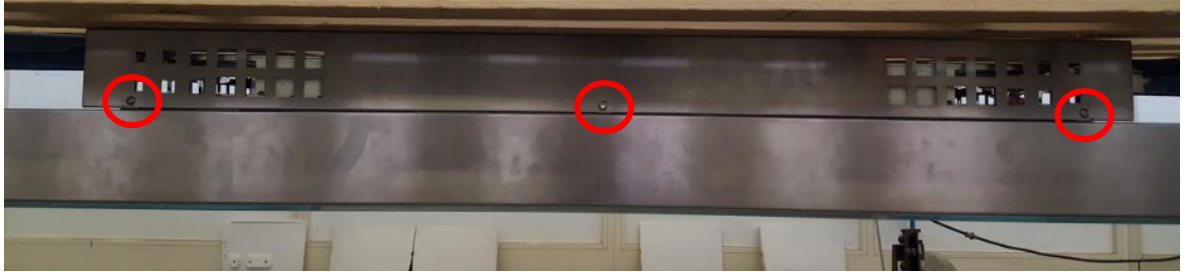
1. Switch off the appliance
2. Unscrew the three screw in the circles (see picture)

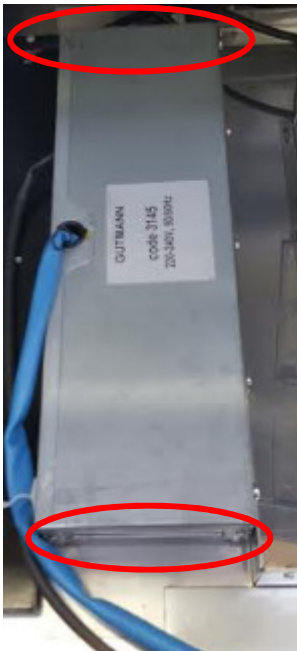
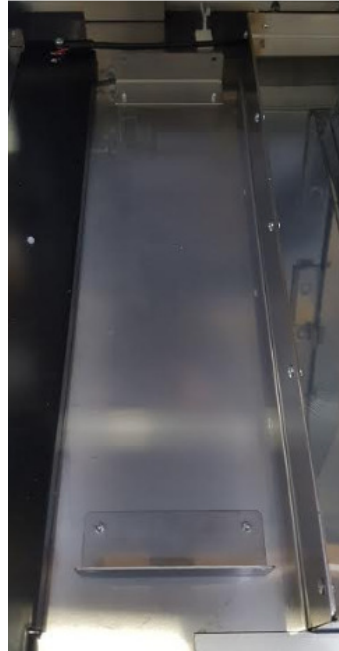
3. In order to change the metal box, unscrew the four screw in the circles

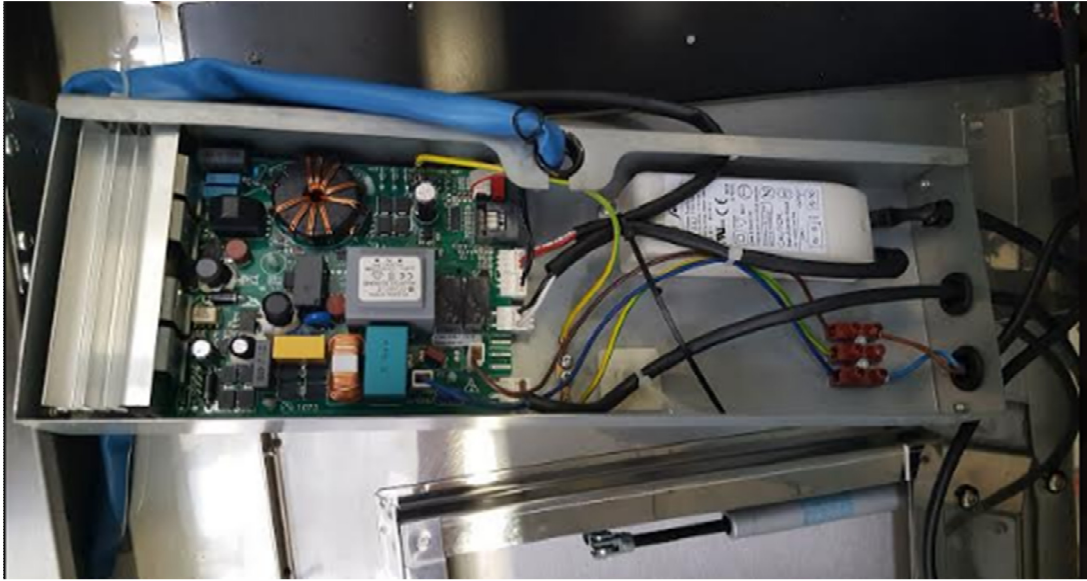
4. Unscrew the screw of the cover

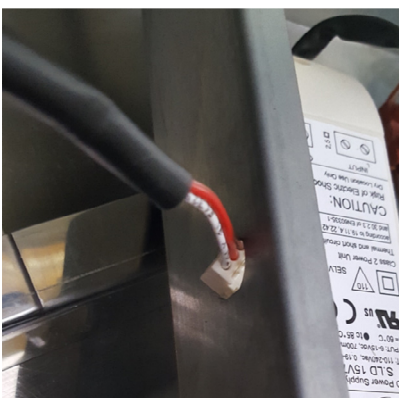
7. Remove all the cables from the box

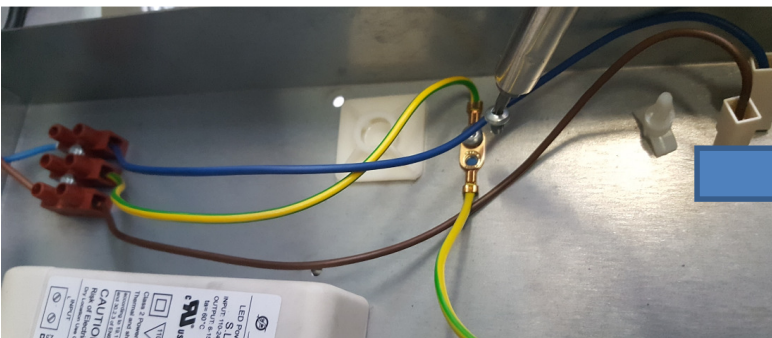
8. Remove the ground connection and the terminal block

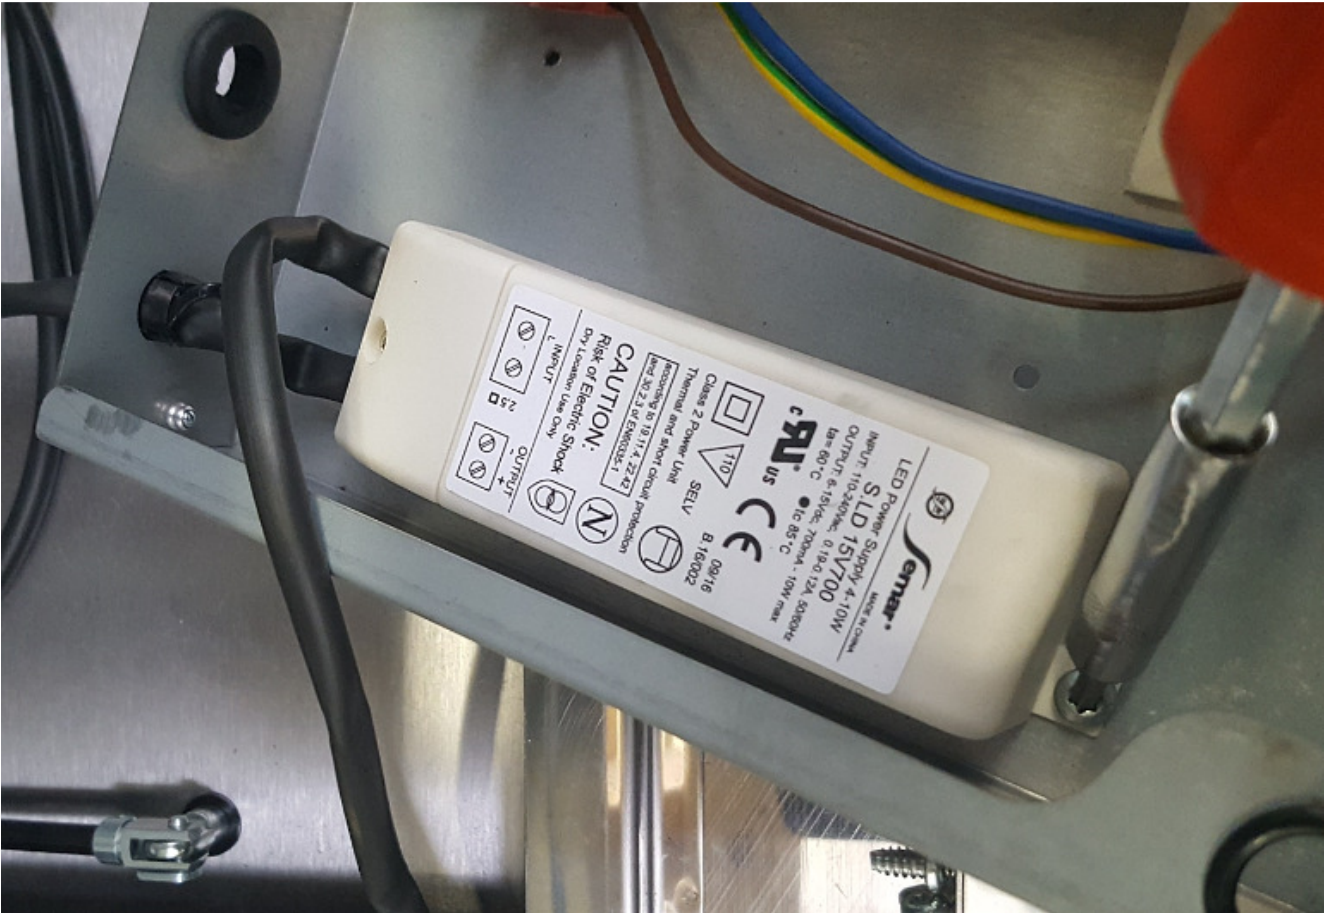
9. Unscrew the screw that fix the transformer on the box

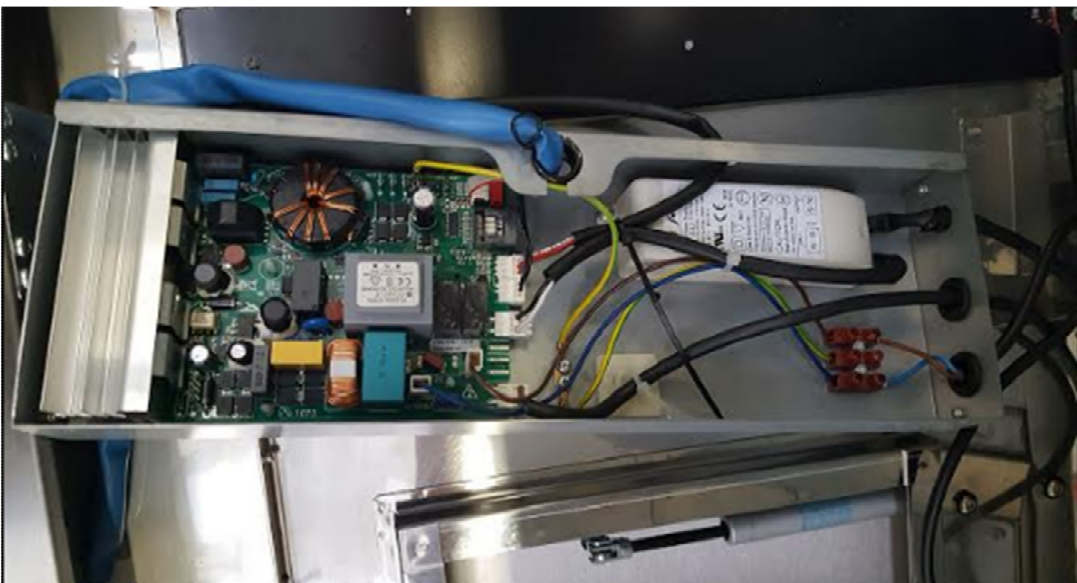
12. Fix the transformer, the terminal block, the ground connection and the main board (see picture).

Fix the cables with plastic band (see picture)
