H2H NOT WORKING ON FACE FLUSH VERTICAL HOOD

DESCRIPTION

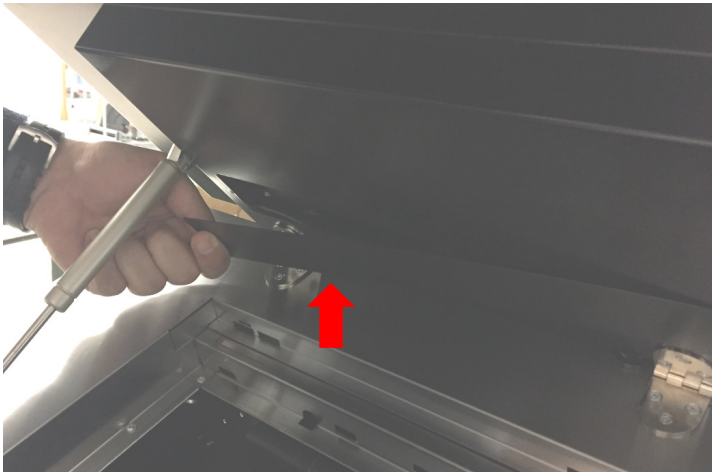
4. Take out the back cover:

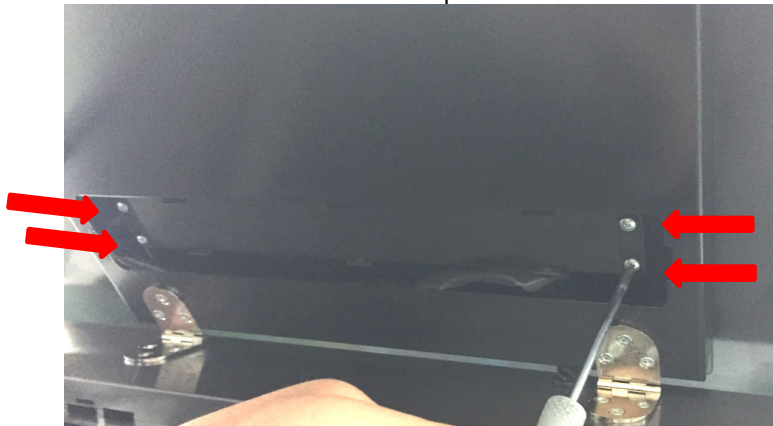
5. Unscrew the 4 screws for back plastic cover fixation:

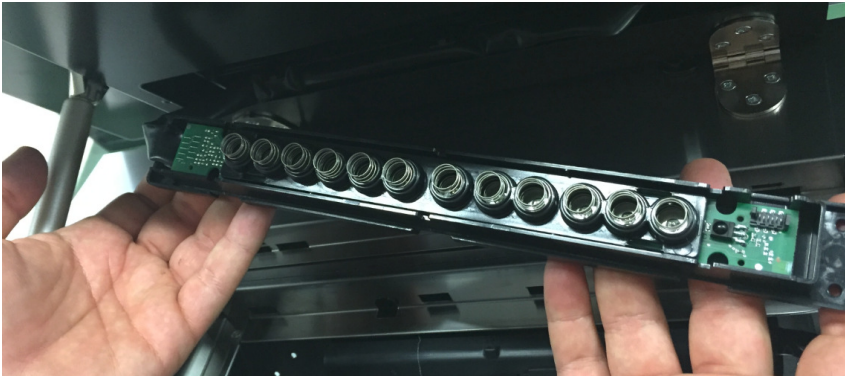
6. Unfasten 6 plastic hinges and take out the plastic cover with user interface inside:
