Moisture formation on middle and lower cross bars of Combi Bottom in high ambient humidity

DESCRIPTION:

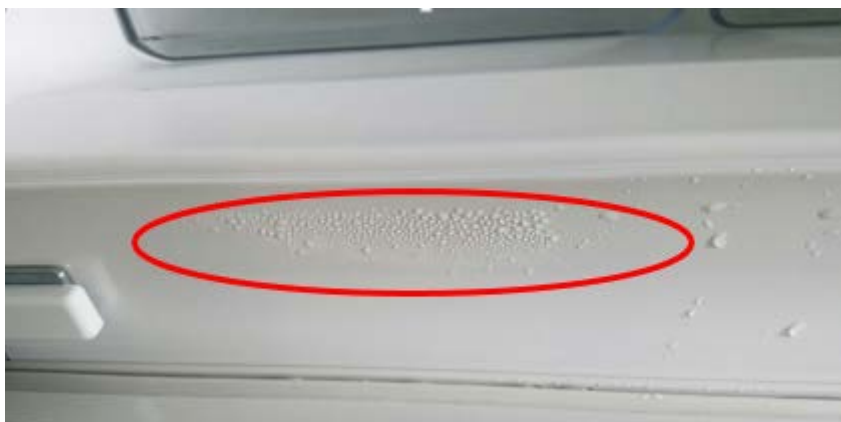
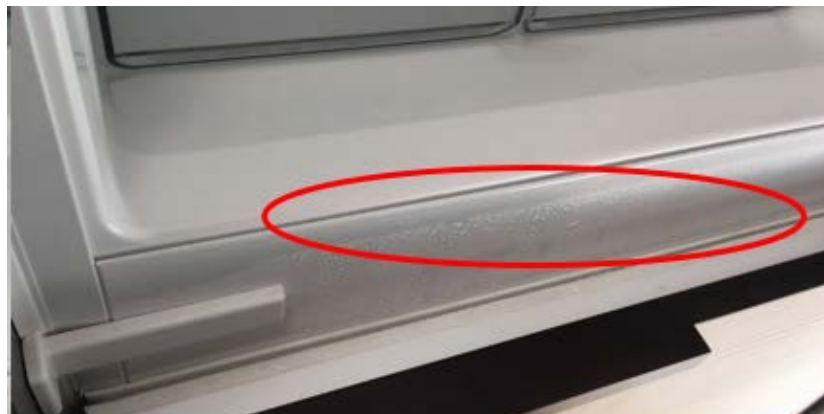
The appliances in subject are involved in the problem of moisture formation on the middle and lower cross bars of the freezer compartment.

This phenomenon has following potential root causes:

1. Very high ambient humidity (over 80 % RH)
2. Lower setting of internal compartment (fridge and freezer)
3. Bad contact of anti-moisture pipe to the metallic cross bar

SOLUTION:

Increase the surface temperature of the cross bars by changing the position of the anti-moisture pipe on the refrigerant circuit.

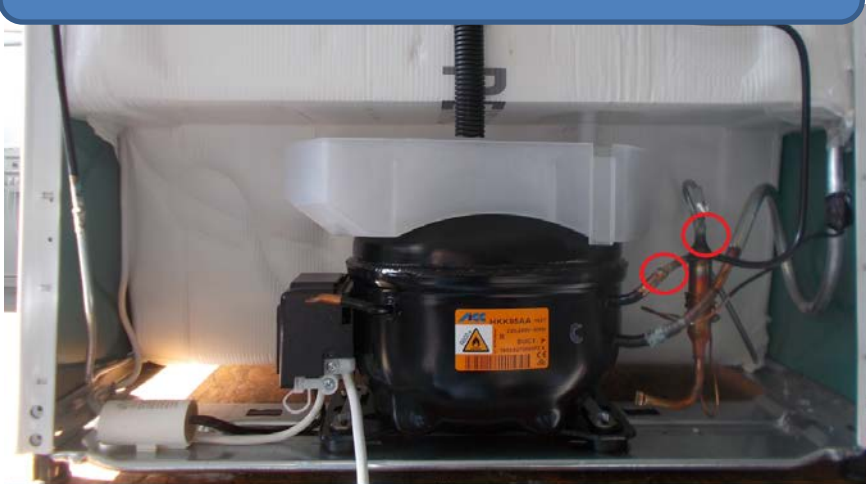
Rear view of combi bottom models before the operation.
The compressors could be standard of with electronic board
Model: Does not matter in this issue

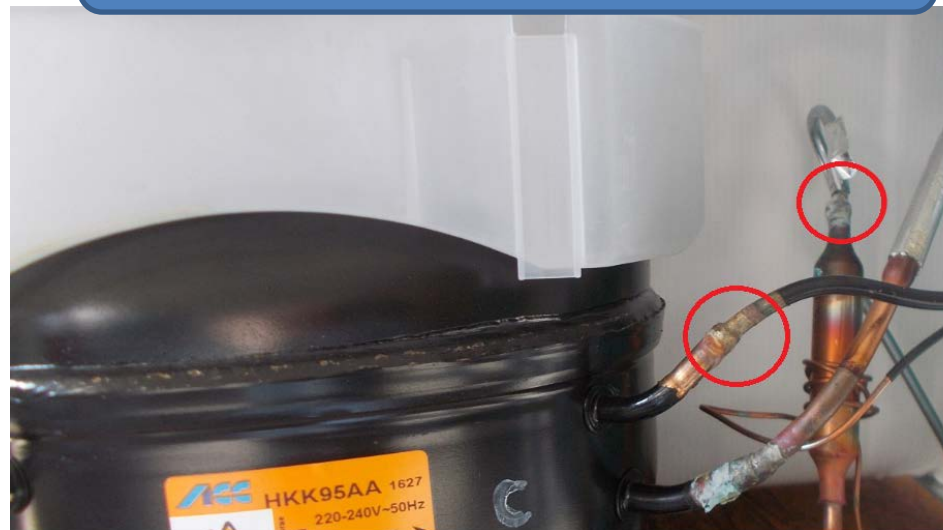
The involved joints to be open are the following:
Compressors - condenser
Anti-moisture pipe - filter

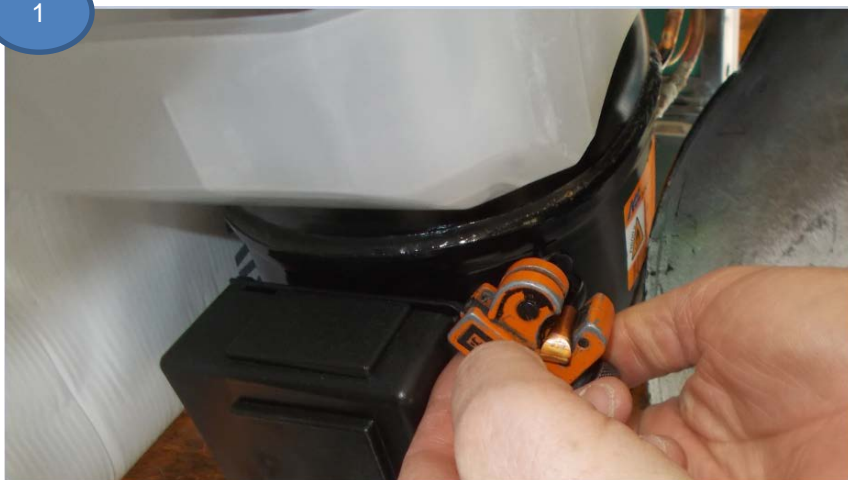
1

1. Open the refrigerant circuit for the gas evacuation.

! Follow the current regulations for the gas evacuation

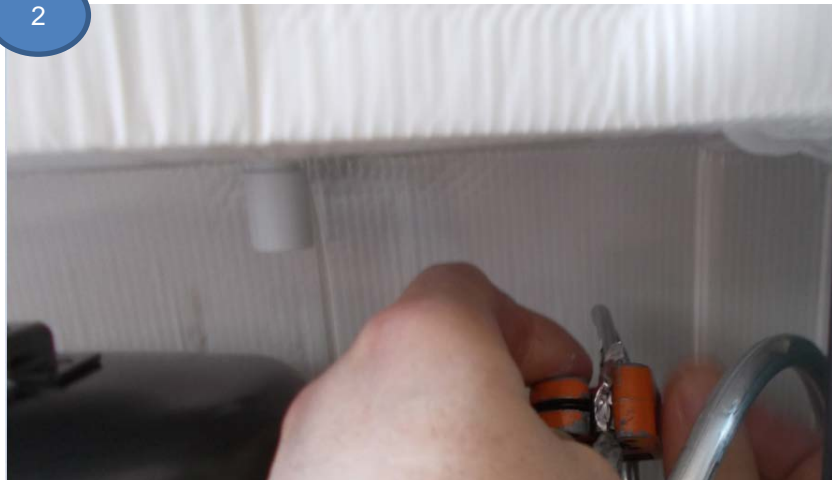
2

2. Detach the filter from the anti-moisture pipe by the brazing flame of the cutter device according to the current technology used in service.

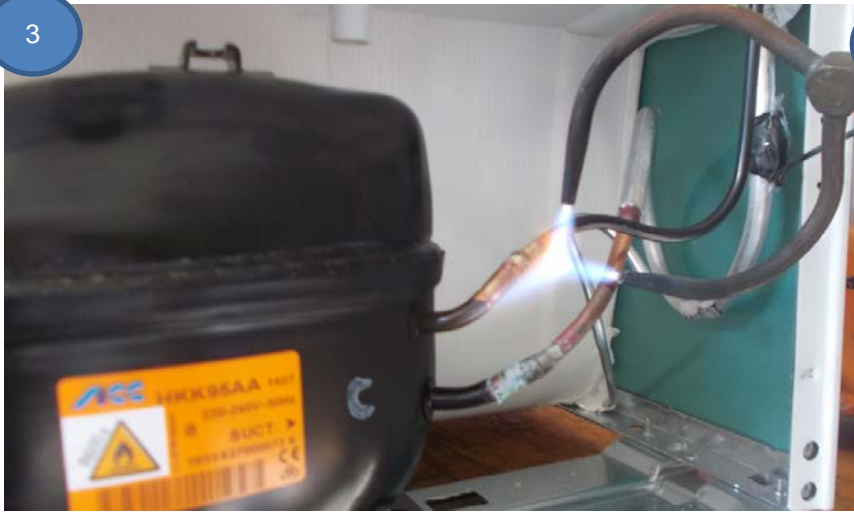
3

3. Detach the condenser pipe from compressor discharge pipe then braze it with the pipe cutter device - according to the current technology used in service.

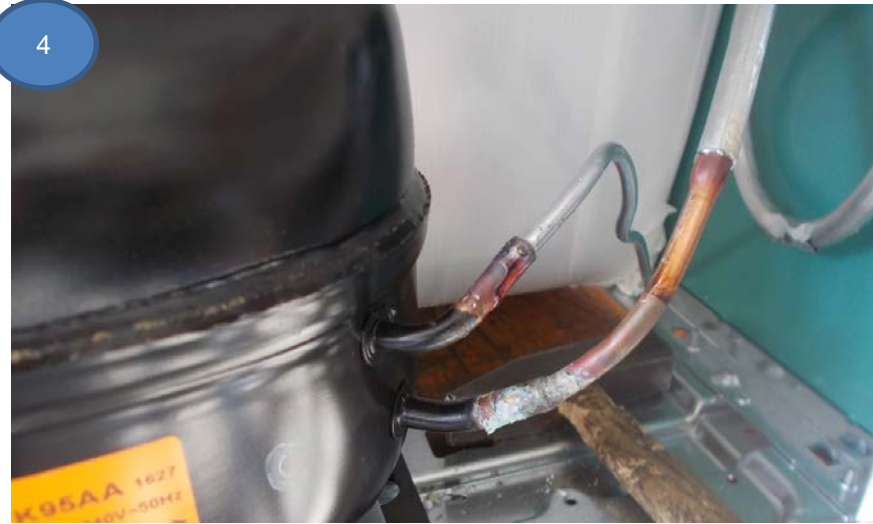
4

4. Clean the compressor's discharge pipe from residuals .Connect the anti-moisture pipe to the compressor's discharge pipe. Braze or use locking joint according to the current technology used in service.

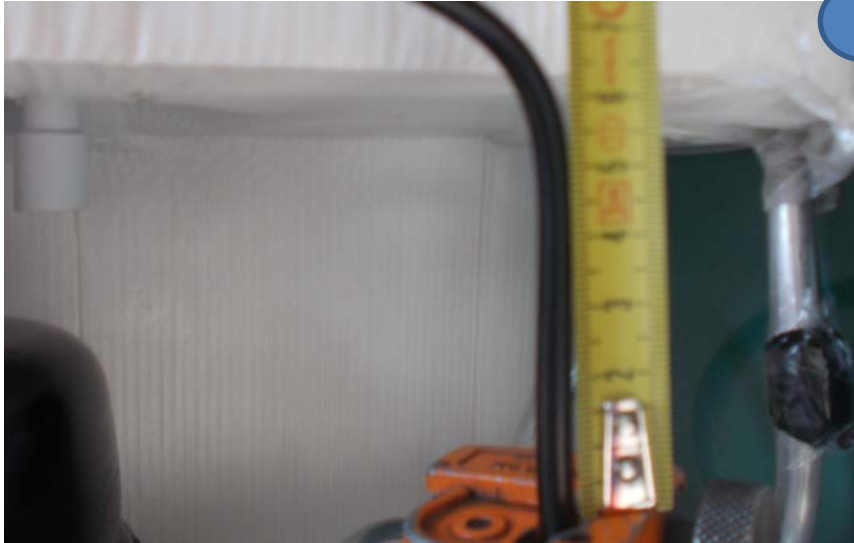
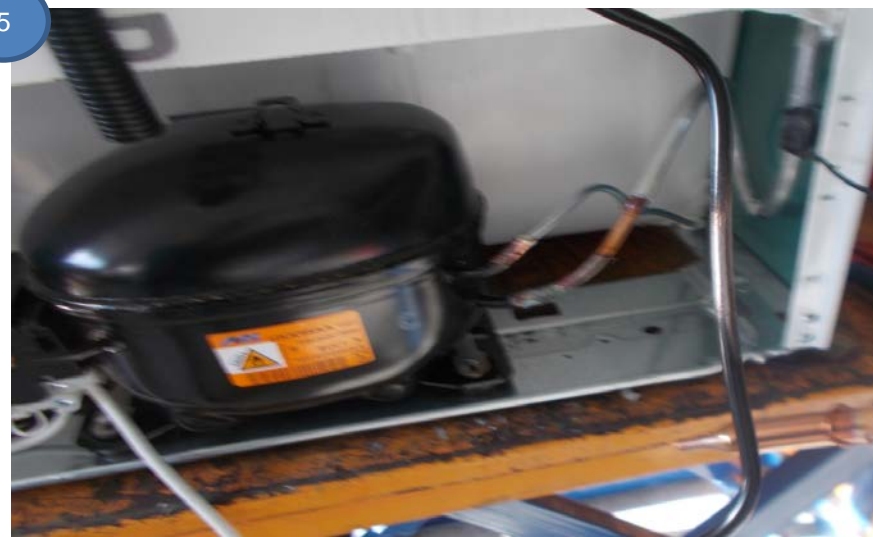
5

5. Adapt the free length of condenser extremity to have the filter in upright position inside the recess of the compressor (see picture 7).

Clean the part to be cut from the paint.

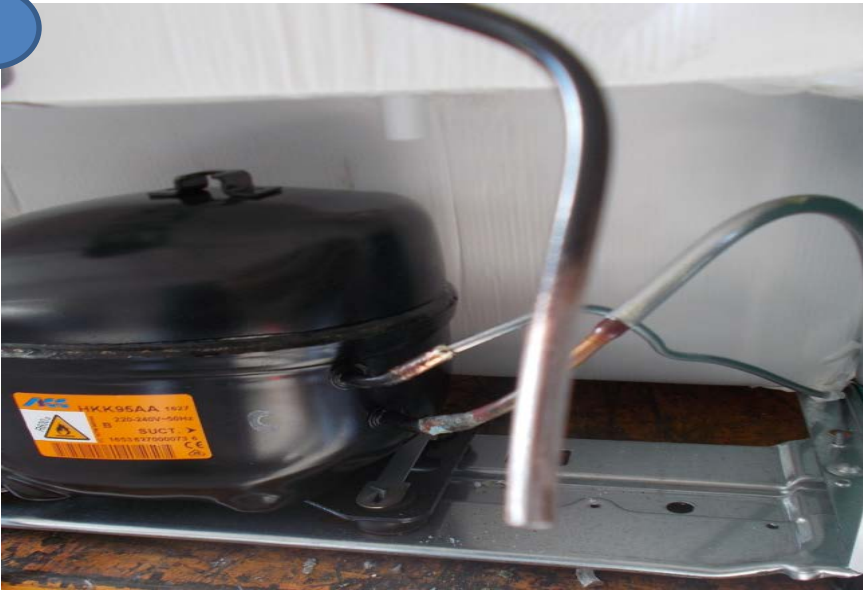
6

6. After cutting, clean the cut extremity of the condenser from the metallic and paint residuals.

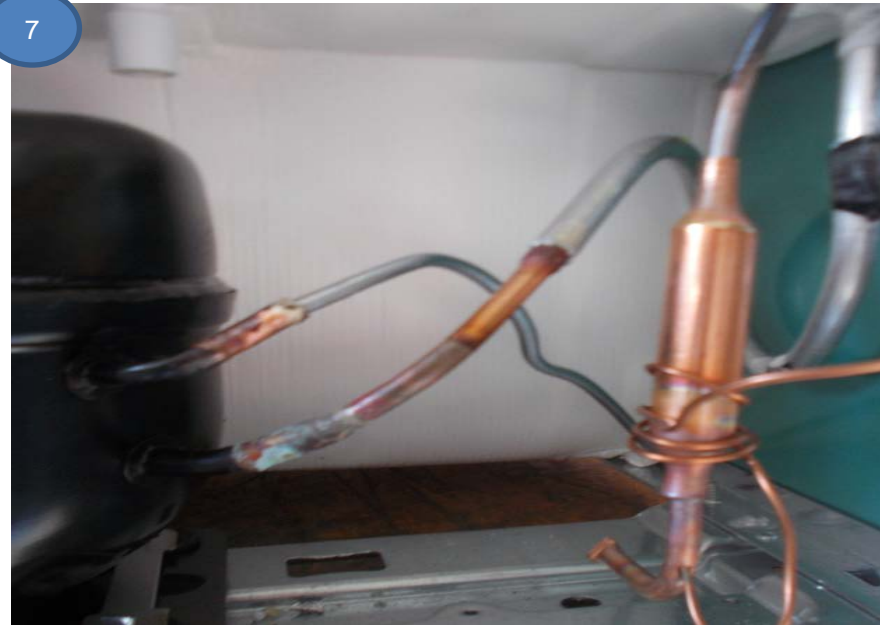
7

7. Bring a new filter. Connect the new filter to the prepared extremity of the condenser pipe.

Braze or use locking joint -according to the current technology used in service.

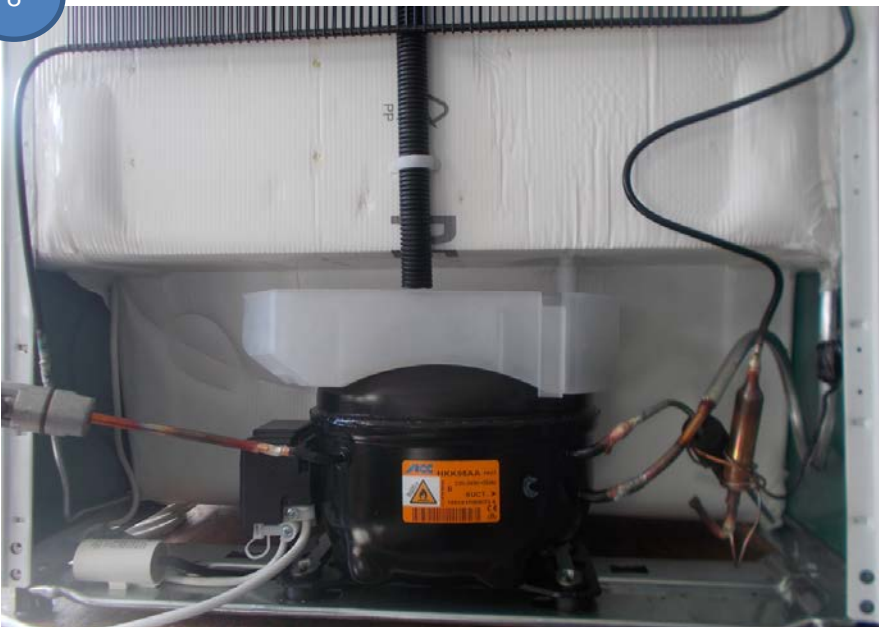
8

8. Final configuration of pipe after operation

After vacuum and gas leakage detection process, charge the refrigerant circuit by the same charge reported on the rating plate of the appliance

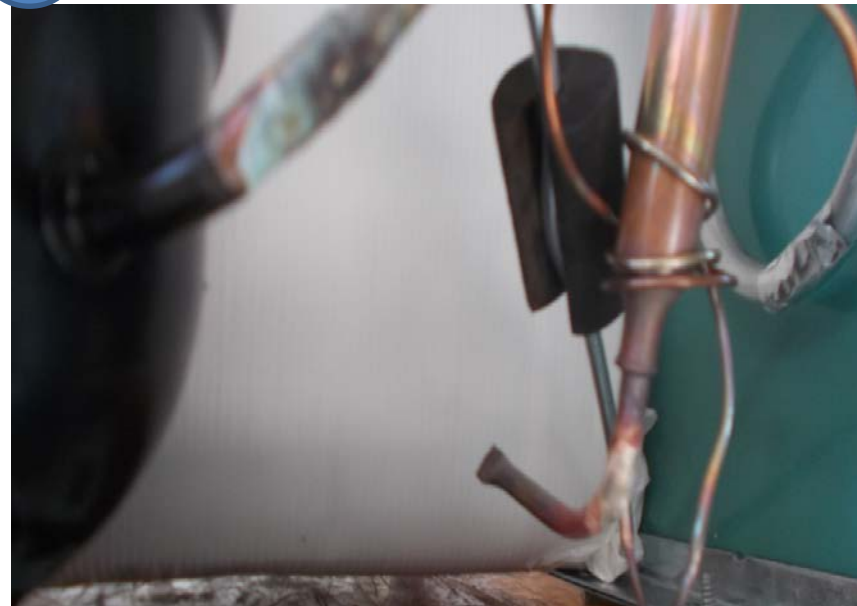
9

9. In case of damper presence on condenser pipe before the operation, put the damper on anti-moisture pipe after the operation.
