Hard to re-open door reduce the time between door openings (FzFF240 and FzFF280)

Issue with door re-opening in free standing freezer appliances.

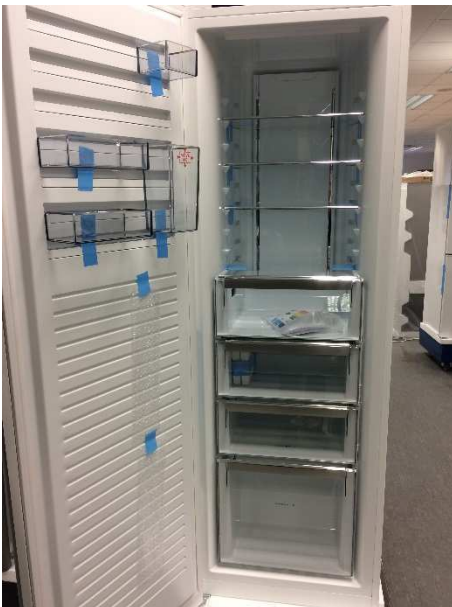
Freezer
FzFF240/280

The cause of the problem could be the attempt to re-open the door immediately after closing. To avoid customer claims, it is possible to implement a valve to reduce vacuum and re-opening time.

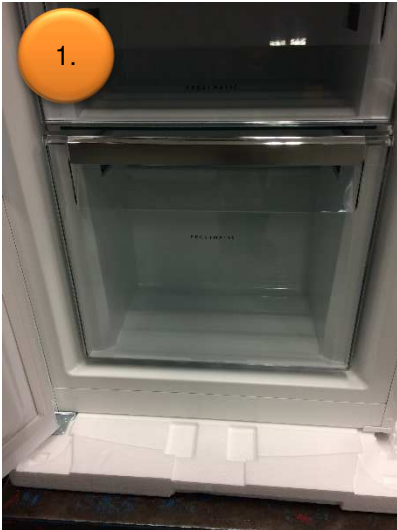
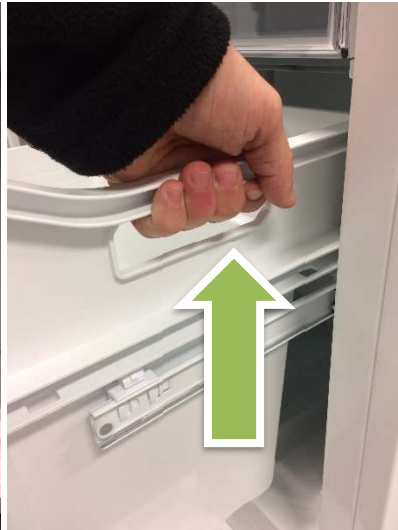
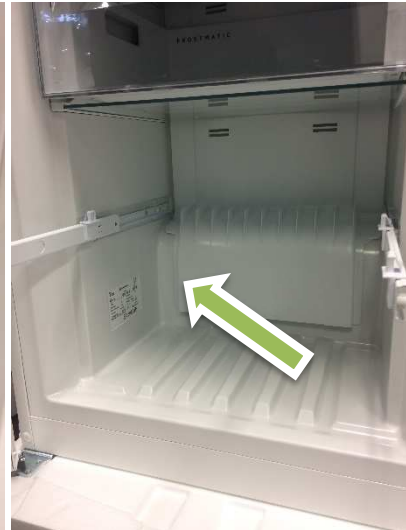
1. Take out the bottom drawer.

2. Drill a hole with a 27mm drill to the left side of the inner liner.

50mm from the bottom and 20mm from the side.

If the hole does not fully penetrate – place the centre tip in the small hole created on the back and complete from the back.

Or if you clean the hole saw, you can “reboot” and finish it from the front side if the drill is long enough.

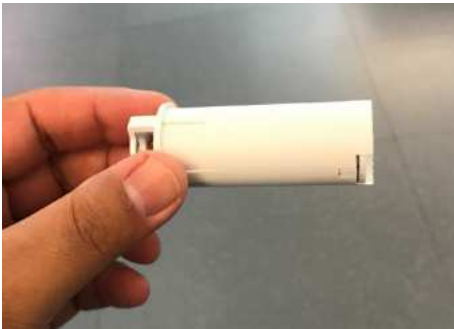
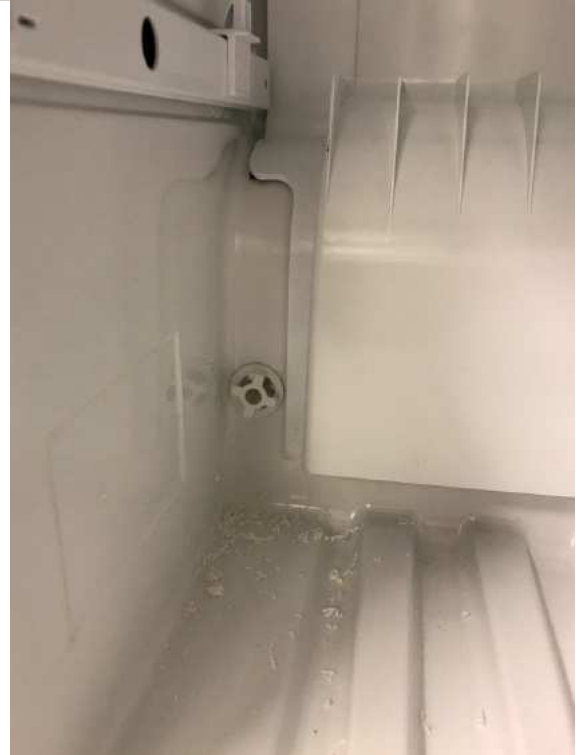
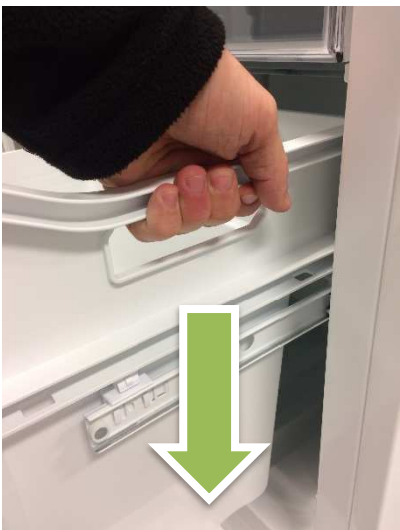
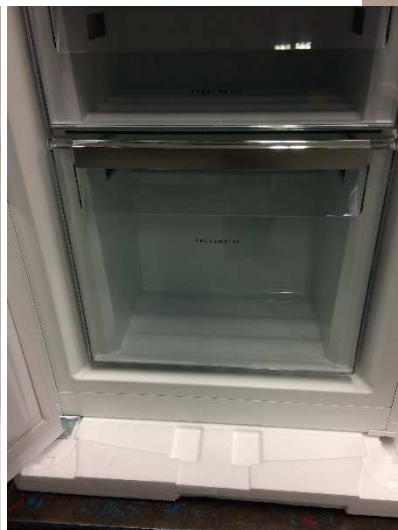
3. Assemble the valve according to the instructions supplied with the valve.
Place the valve in the hole.
Put back the drawer.

Spare part number	Description
4055269494	Valve, Kit
