## DOOR LATCH BROKEN

All condense dryers and heat pump dryers with plastic door latch

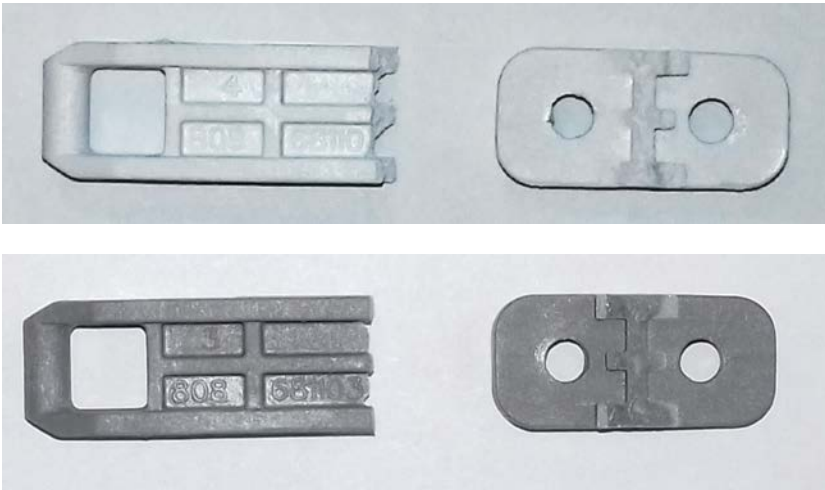
Consumer reports that the door latch is broken. Problem can occur due to mechanical stresses in the material.

Replace the broken door latch with a new spare part:

| Spare part number | Description |
|---|---|
| 8086811083 | catch, porthole, glass door, Pilot2 |

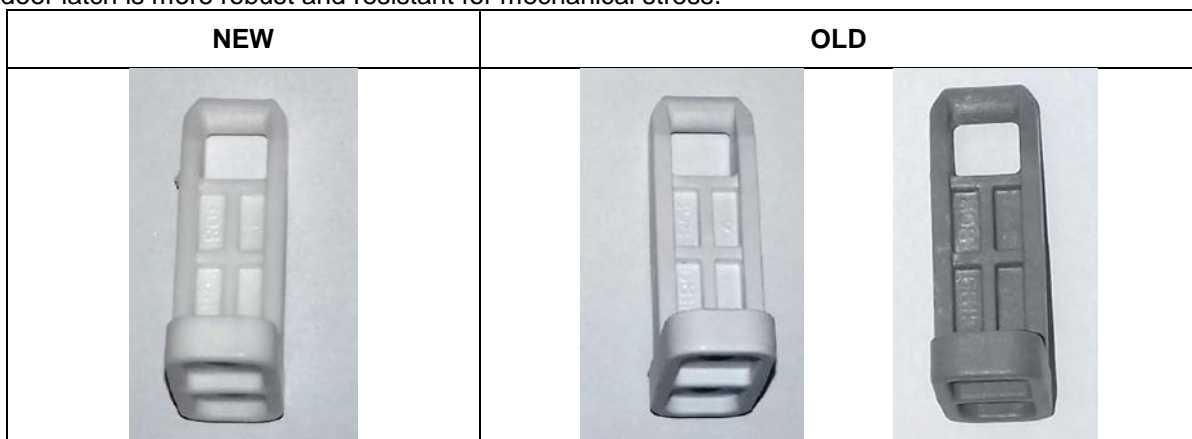
New door latch is more robust and resistant for mechanical stress.
