DOROTEA-DOMODOSSOLA: 2nd Gen. Auto door open

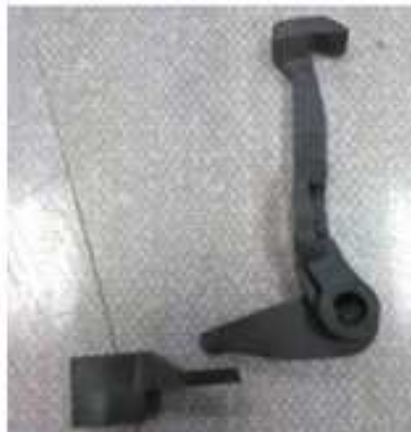
The cause highlighted from the analysis of the faulty parts is the breakage of the micro activation lever of the ADO

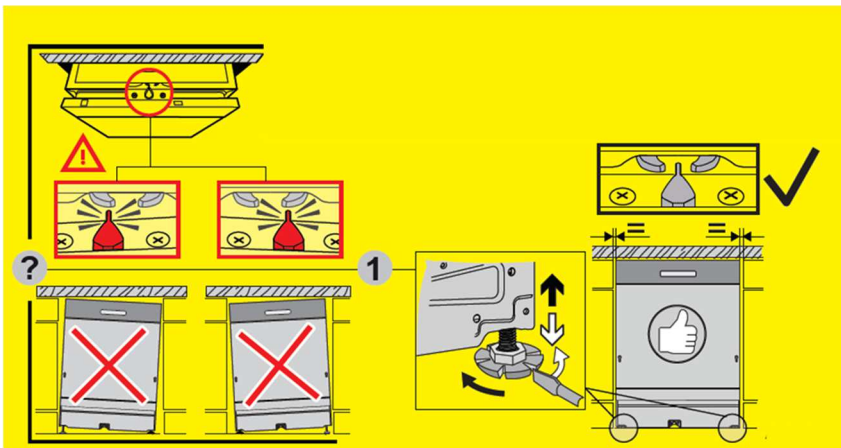
- a) The diamond must be centered between door lock catchers.

In case of intervention is important to check that the dishwasher is levelled correctly and that the structure or the inner door has not been deformed during the handling/transport
