SERVICE MANUAL

DISHWASHERS

Dishwashers with electronic control system

COMFORT LIFT

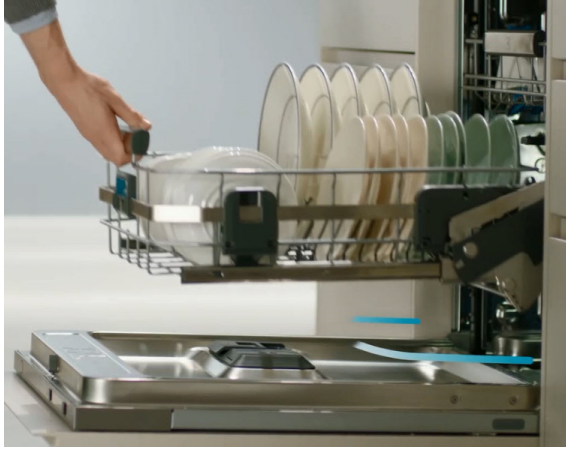
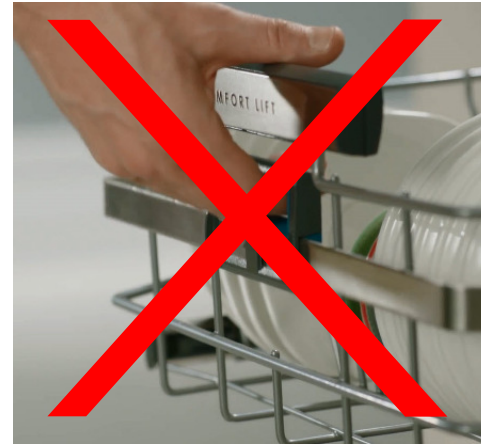
Lift the basket

Pull the handle off the basket.

Don't pull the unlocking handle

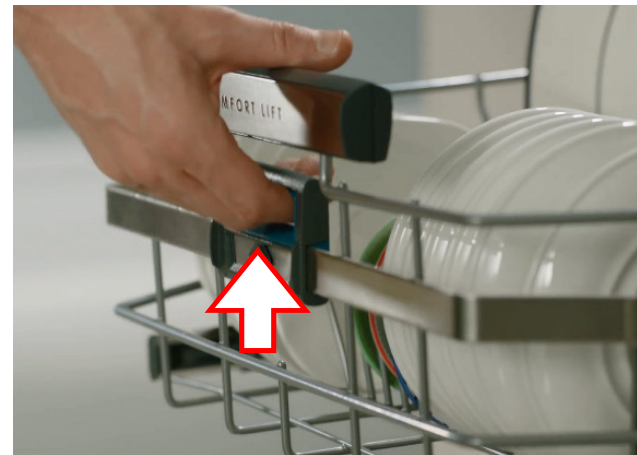
Lower the basket

Pull up the unlocking handle to lower the basket.

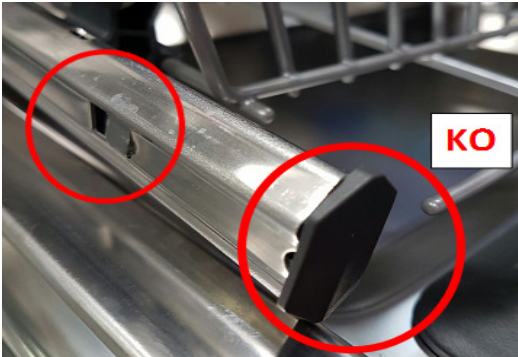
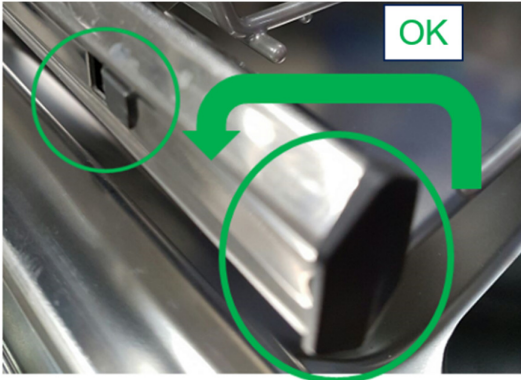
Failure description	Cause	Action to perform
Basket stuck or difficult to move.	Basket front stoppers bad positioned	Put front stoppers on the correct position. After fully inserting the stopper completely, rotate it towards the outside of the guide to create the correct interference with the fixing hole on the guide itself.
Basket coming out from basket rails.

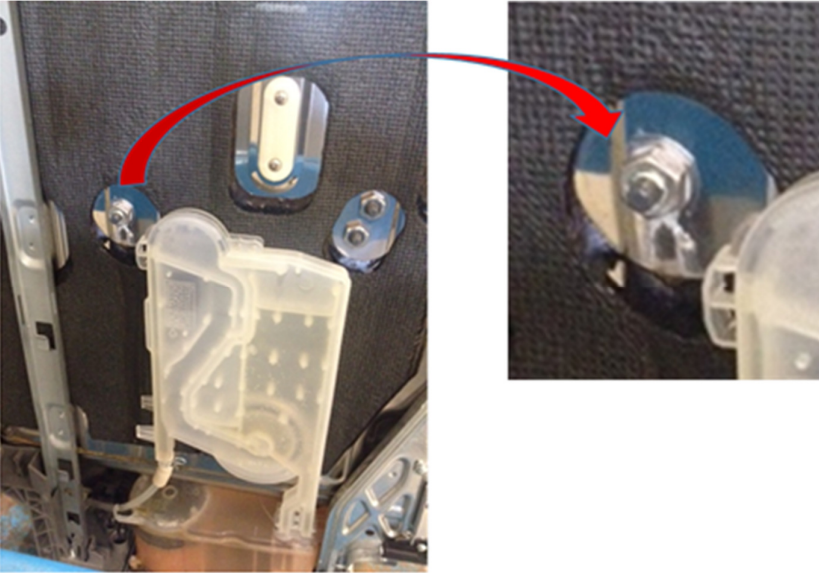
Failure description	Cause	Action to perform
<p>Alarm I30 because of water leakage on the sides of the tub</p>	<p>Water leakage from the nut of the comfort lift module.</p>

<p>Tighten the nut but also add the Loctite (see below) on the thread. To avoid the same problem in the future add the Loctite on all the threads and tight all the nuts of the module. Use a manual tool not a automatic one (max force torque 4,5Nm).</p>

<p>More information at the chapter "Tub bracket replacement".</p>

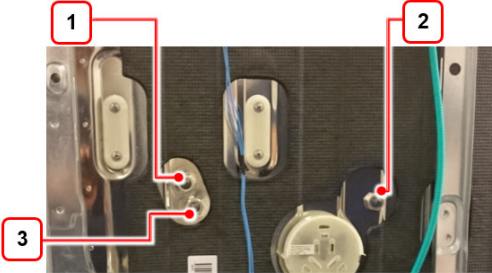
<p>Sequence of tightening the nuts.</p>

<p>3- Place the new tub bracket and screw the 3 interior screws with manual screwdriver, not automatic one (max force torque 3,8Nm).</p>	<p>4- To fix from the exterior of the tub start with the upper front nut. Use a manual tool not a automatic one (max force torque 4,5Nm).</p>
<p>5- Then the rear nut. Use a manual tool not a automatic one (max force torque 4,5Nm).</p>	<p>6- And the last is the the lower front nut. Use a manual tool not a automatic one (max force torque 4,5Nm).</p>

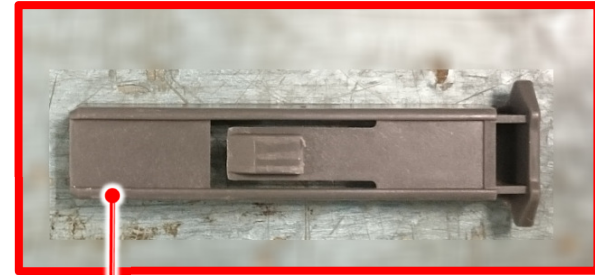
To disassemble the basket, **it is necessary to have it on the lower position**, otherwise the lifting mechanism locks the basket and it is not possible to disassemble it.

1- Press the snap to remove the plastic locking part (front stopper)	2- With the snap pressed, pull the plastic lock.
3- Do this operation on left and right side rails

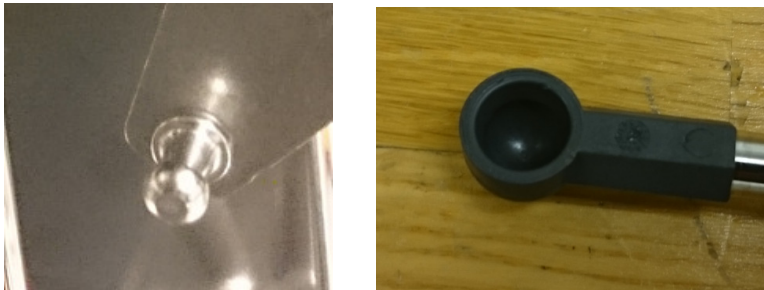
The soft movement of the mechanism is possible because of this gas damper.

Any operation of disassembly or assembly of the damper must be done with the lift mechanism on lower position; the damper must be on the position shown on the picture above.

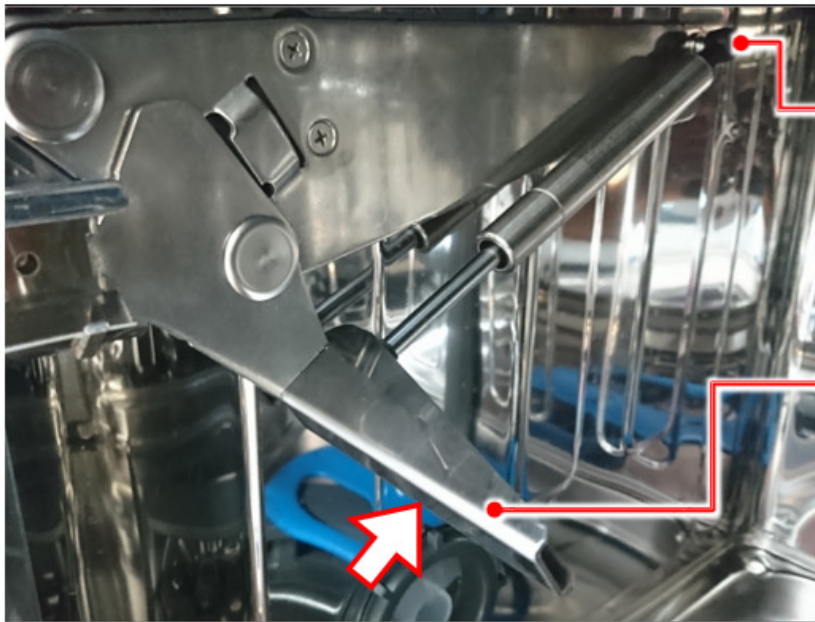
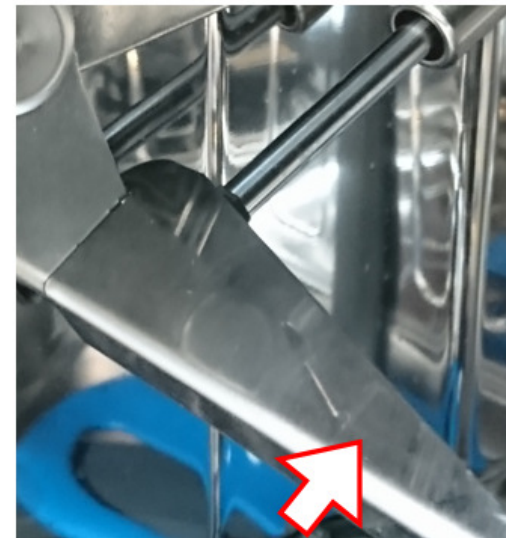
3- Lift the lower basket

4- Snap the damper on inner position of the tub first

5- With the metallic tool compress and snap the damper on the position closer to door.

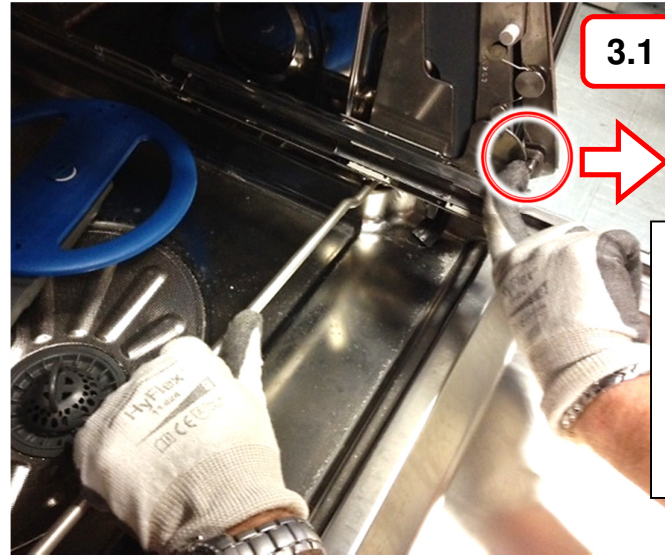
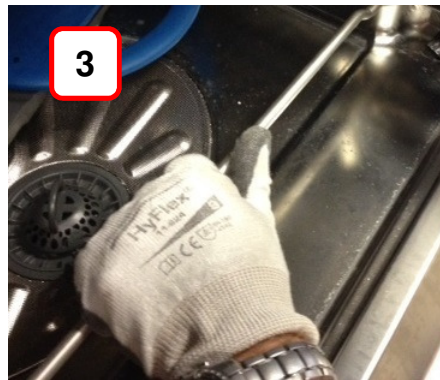
2- Slide out the two guides

Keeping the syncro bar firm with one hand, unlock the right side pin.

3- Keep the syncro bar firm with one hand.

3.1 - Unlock the right side pin.

3.2 - Unlock the left side pin.

3.3 - Lift the system up.

Keeping the syncro bar firm with one hand, unlock the left side pin.

Keeping the syncro bar firm with one hand, lift the system up.

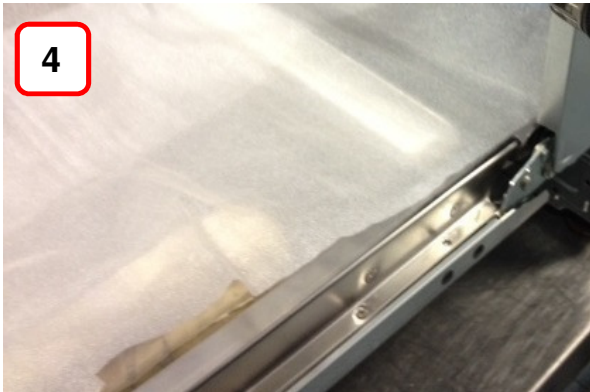
4

4- Place protective foil on inner door and tub to protect them from debris

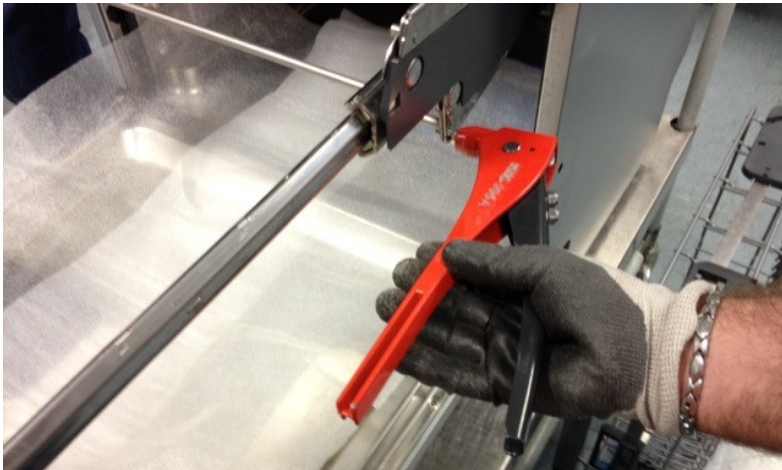
12- Position the new syncro bar like the picture (bending inside)

13- Fix the syncro bar with 4 rivets (2 per side) with manual rivet machine (spec.: able to fix 5mm iron rivets)

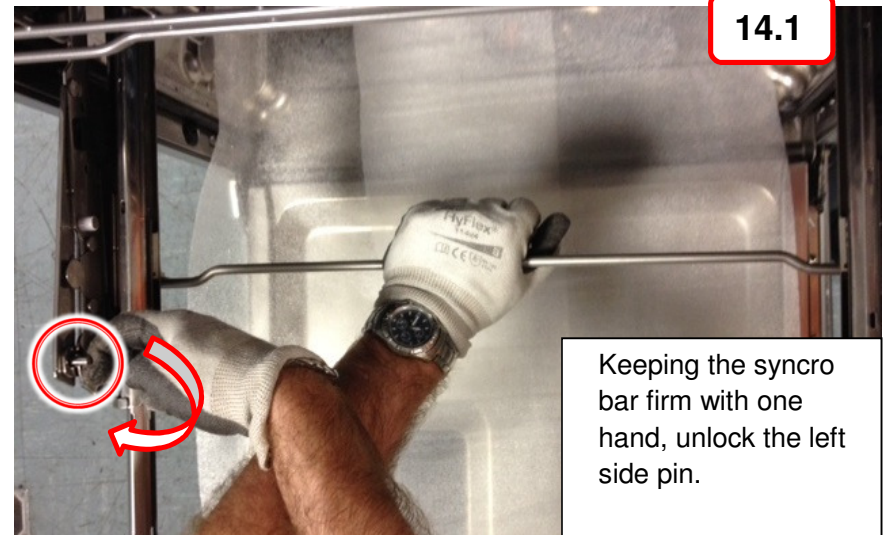
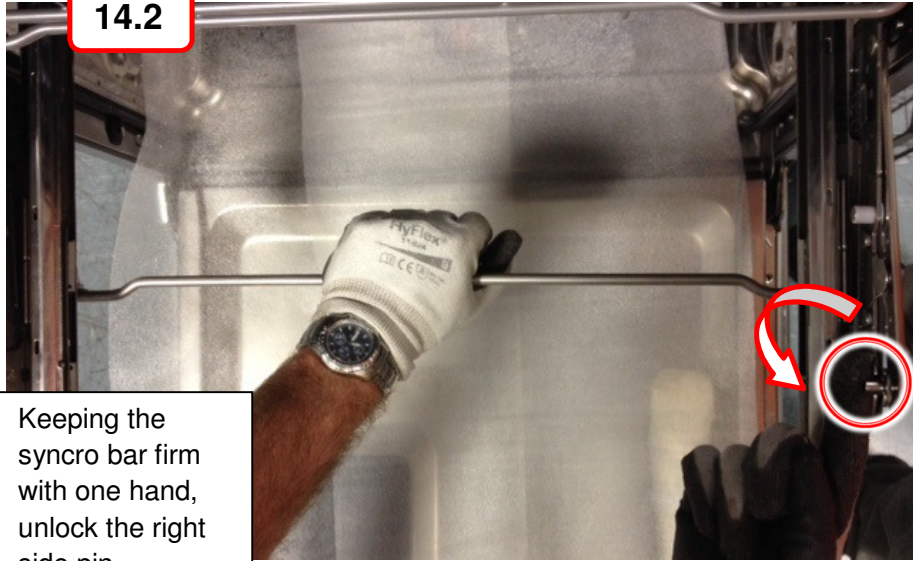
Keeping the syncro bar firm with one hand, unlock the left side pin.

Keeping the syncro bar firm with one hand, unlock the right side pin.

Keeping the syncro bar firm with one hand, push the syncrobar into the tub.

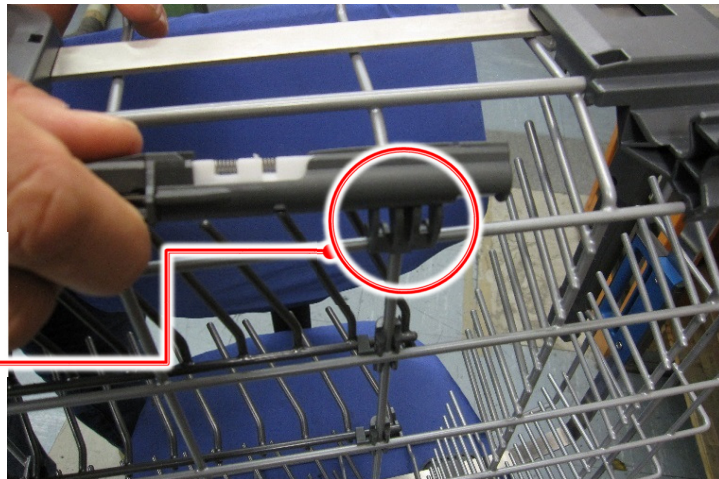
2- Identify Self closing unit in red rectangle

3- Use screw driver to unlock Self closing unit .

4- Unsnap the Self closing unit from basket.

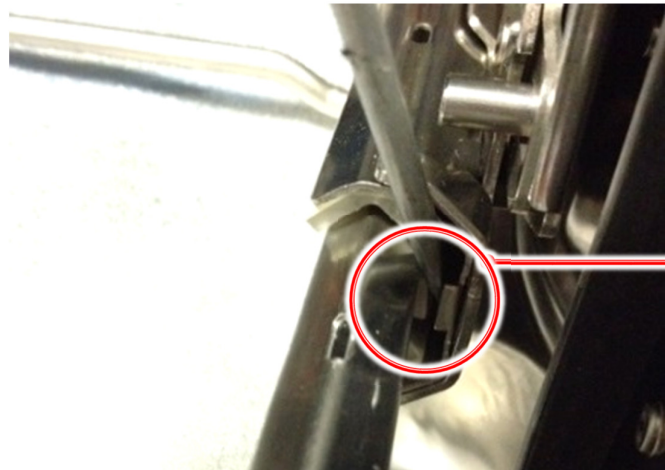
1- Put the screwdriver inside the guide to push the plastic tooth to unlock it.

2- Move the rail out to slide out the roller cage.
