## Combi bottom frost free - cracking noise

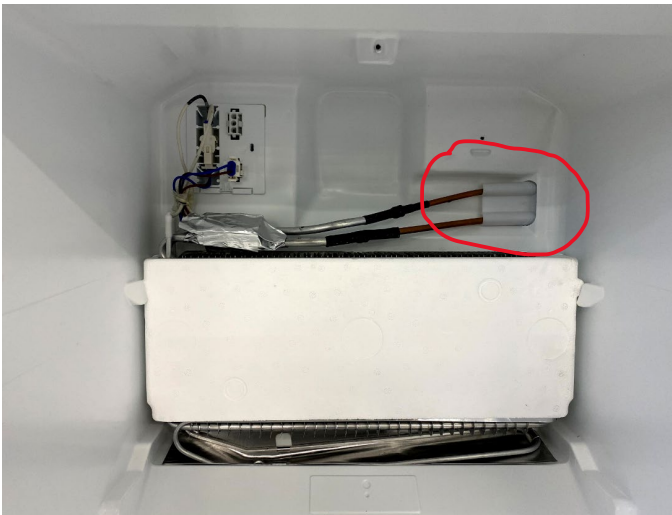
The noise comes from the plastic assembling guide used for the pipe. This was introduced in production in week 29/2019.

Seal the plastic guide using Silicone with spare part 4055071353 -Sealing compound.
