Vibration noise in 1780 static combi bottom and cabinets

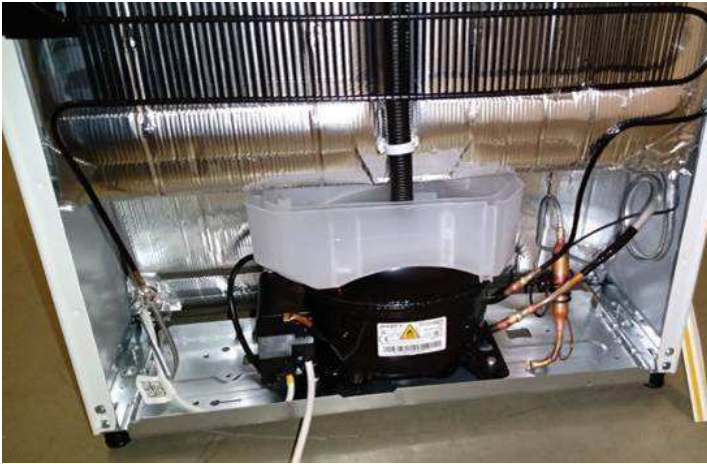
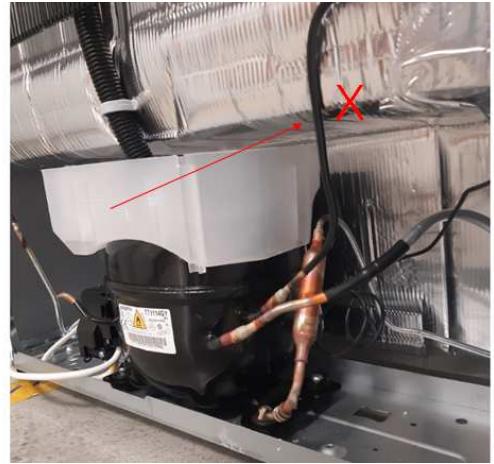
The noise comes from tubes vibrating against the back of the appliance.

Carefully bend the tube away from the back of the appliance.
