HOOD - FRAME FALLING

Frame of Cooker Hood is falling down.

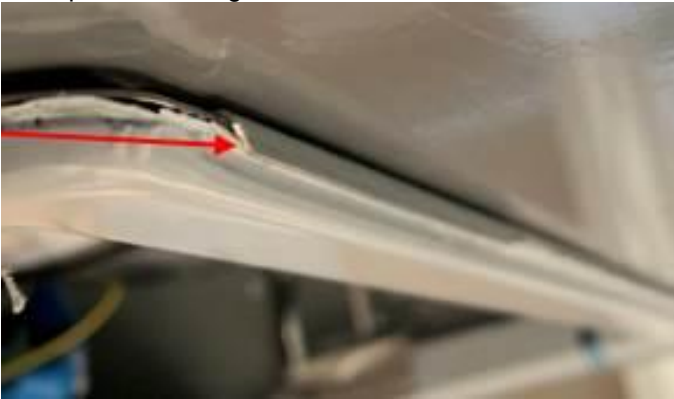
Example A: Housing located outside of frame

Improper placed frame during installation (example A, example B) of product or after cleaning of appliance.

Proper installation of product. For more info: <https://youtu.be/tKchQDCoJ7Y>
Or search for video:

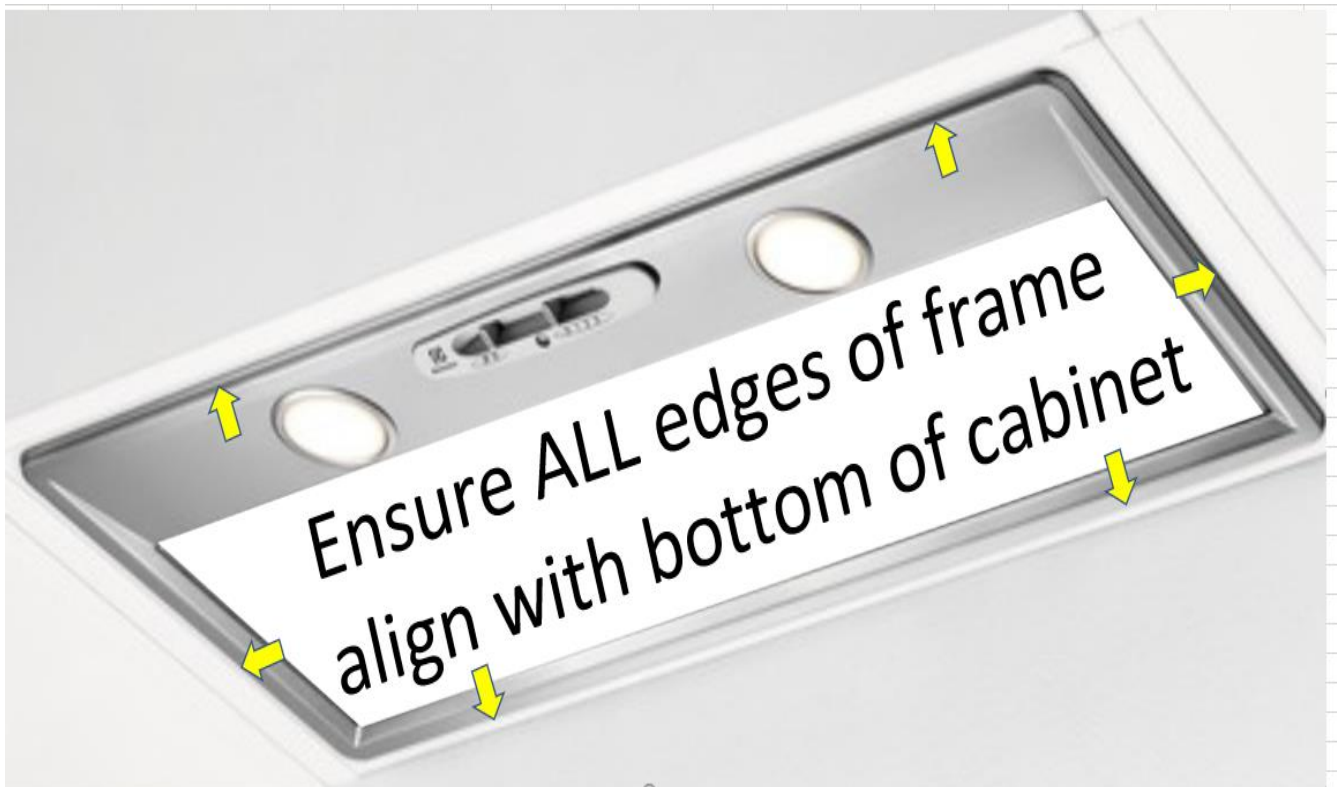
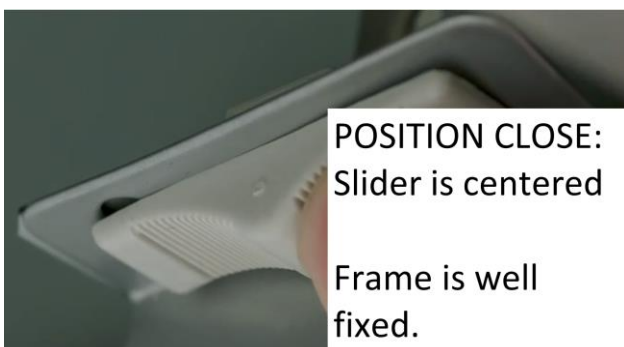
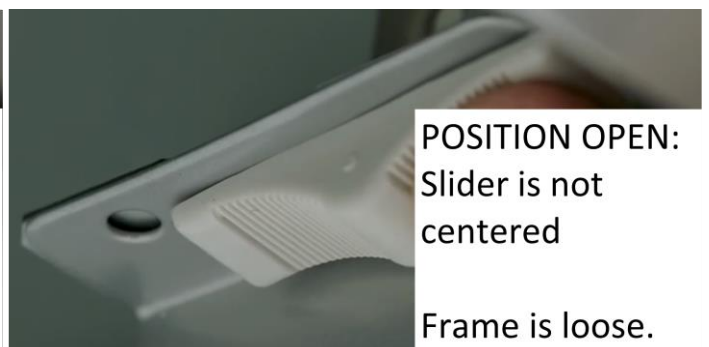
- Proper installation of product step by step:
- 1) Remove protective film from all areas of inox steel frame
 - 2) Align frame with housing and tighten sliders.

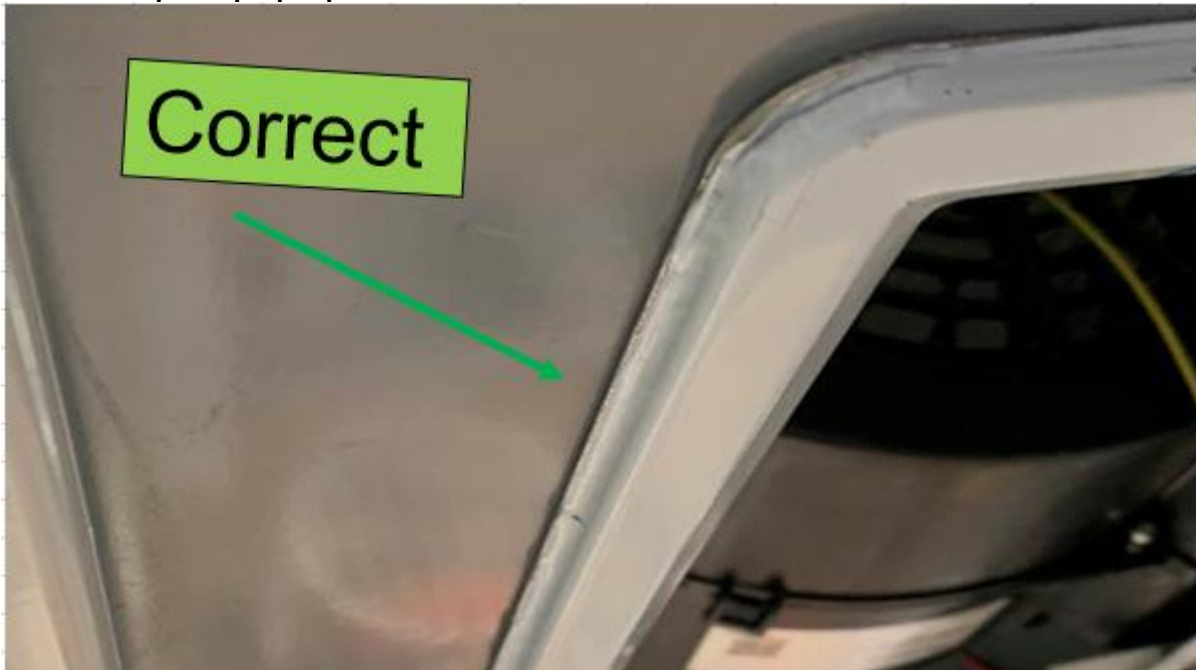
Below example of proper position of frame:
