**Technical Bulletin N° CB1021**

## Noise or Vibration

Three areas of noise or vibration have been identified with this product and have been addressed at the factory at three different serial number break points.

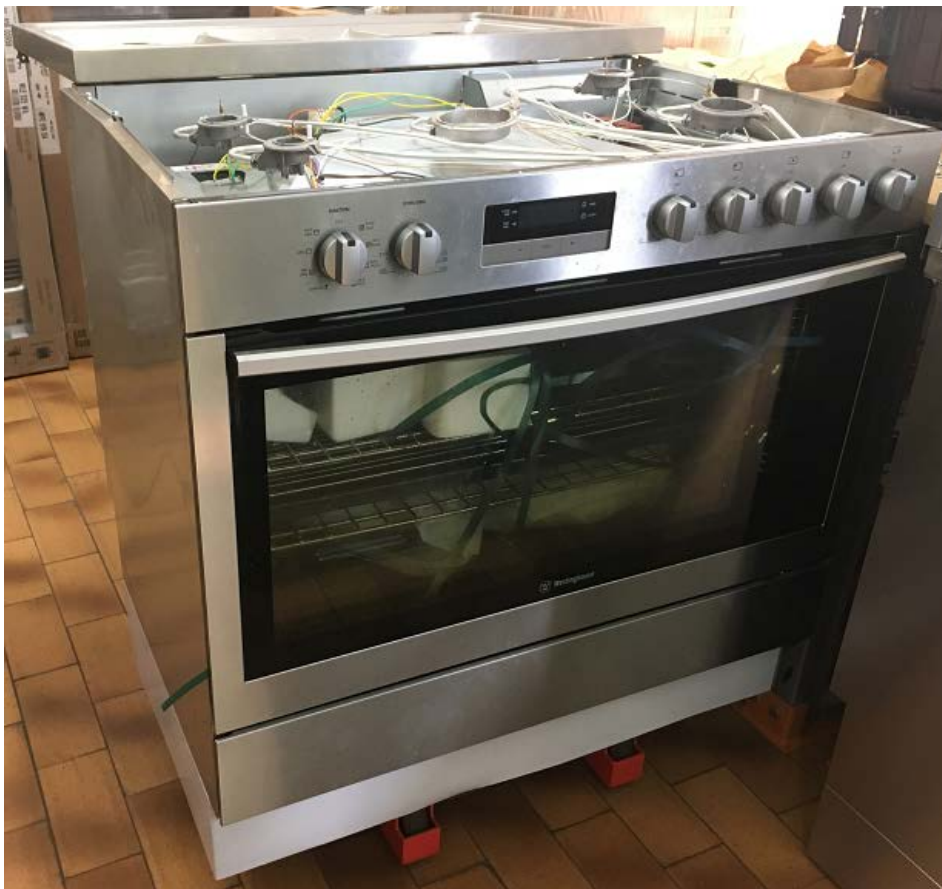
## Panel deck before serial number 73400000

Due to the large panels used in the cooling fan duct, there is a possibility some vibration and noise can be generated in this area.

Applying some silastic (Part N° 0393 001 065) in the areas shown will stop this possibility.

1. Remove the hob

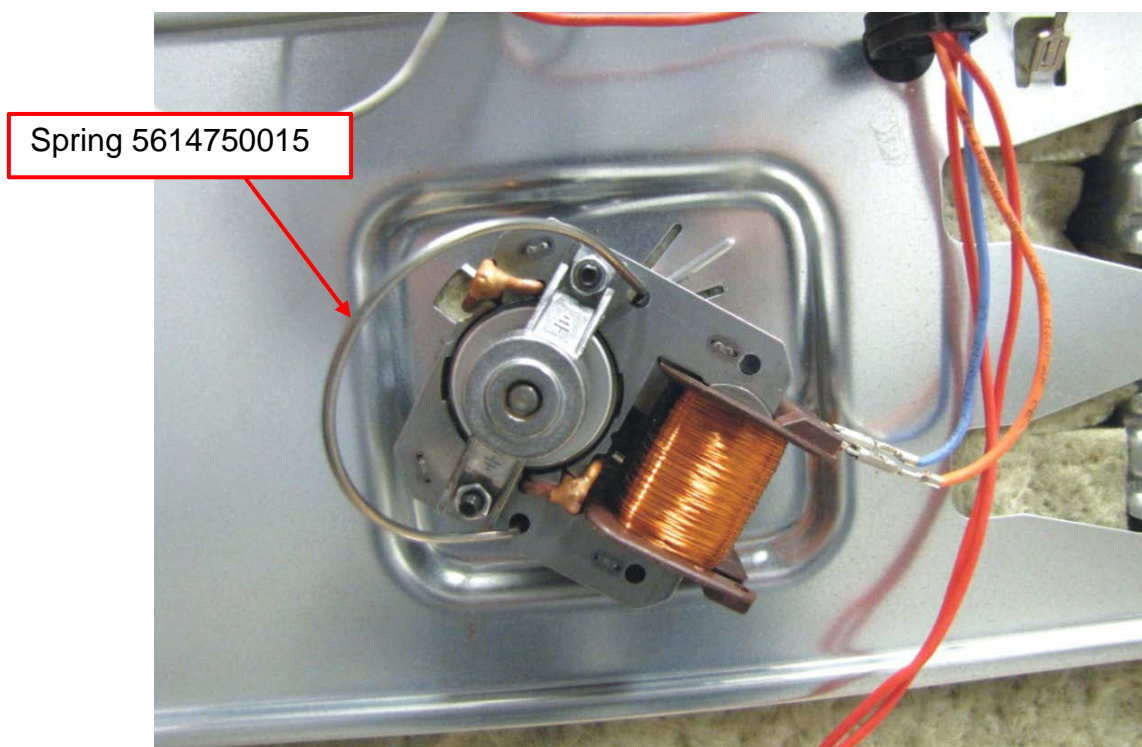
### Oven fan motors before serial number 74100000

A noise can be heard at start up or when the oven is hot while using fan element cooking.

When the fan motor is running it produces a magnetic field which can cause vibrations therefore creating noise on the back panel of the oven.

A spring (Part N° 5614750015) should be fitted to the motor as shown in the picture below.

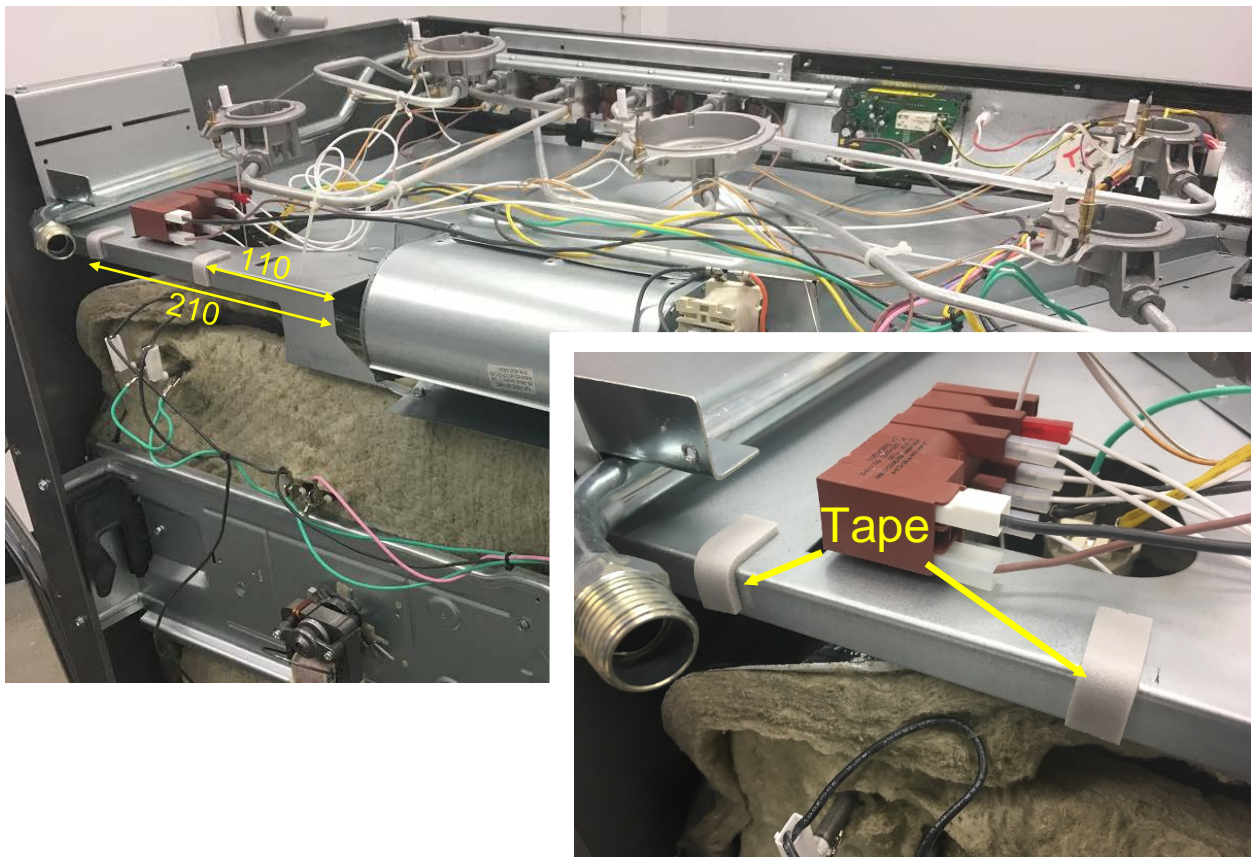
## Rear panel regulator recess before serial number 74500000

Vibration between the rear panel and where the regulator recess touches the panel deck can sometimes cause issues. Fit some tape (Part N° 0400 005 006) in 2 places as shown below.

Extra pieces of tape can be added if required.
