Technical Bulletin N° CEB101.docx

Vulcan 90cm Oven cutting out.

Models: WVE916
WFE916
WFE946

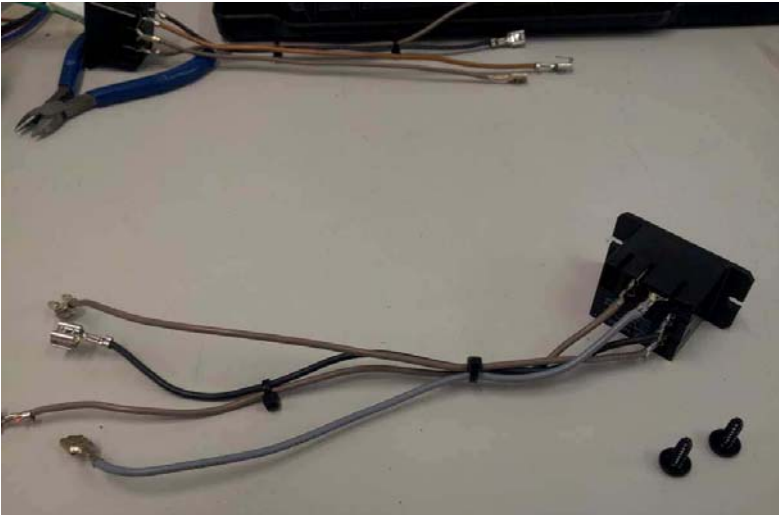
Kit consists of a relay, 4 wires, 2 screws and a klixon.

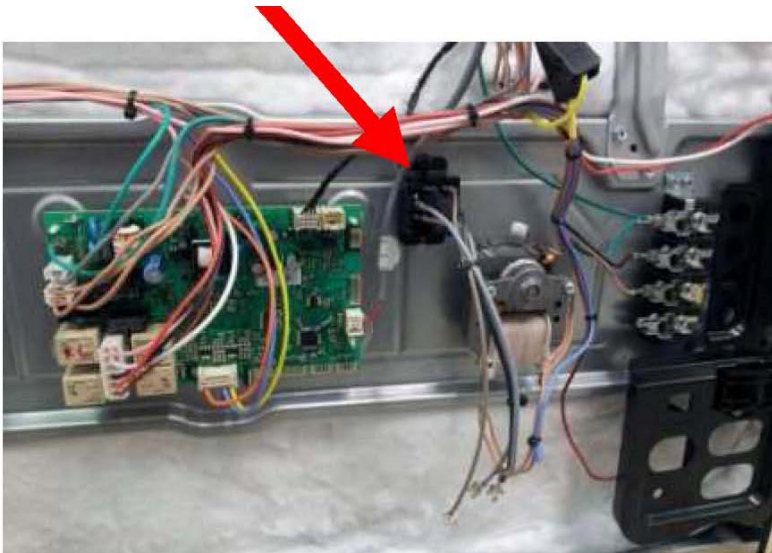
1. Using the provided screws install the relay in the location shown.

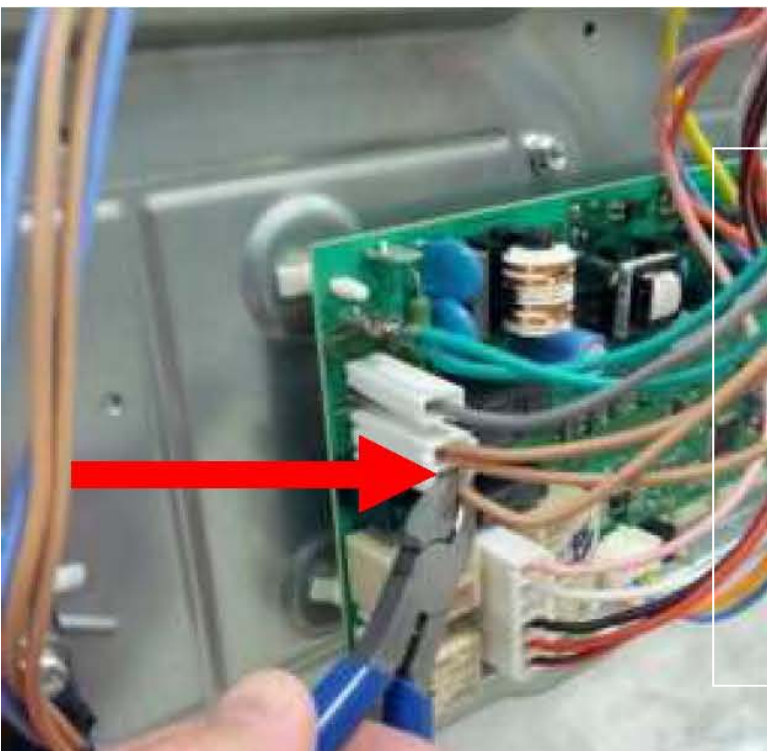
2. Cut the single Brown wire at the powerboard as close as possible to the terminal.

NOTE: Ensure the double wire is not cut.

Feed this wire back through the cable ties to the fan element.

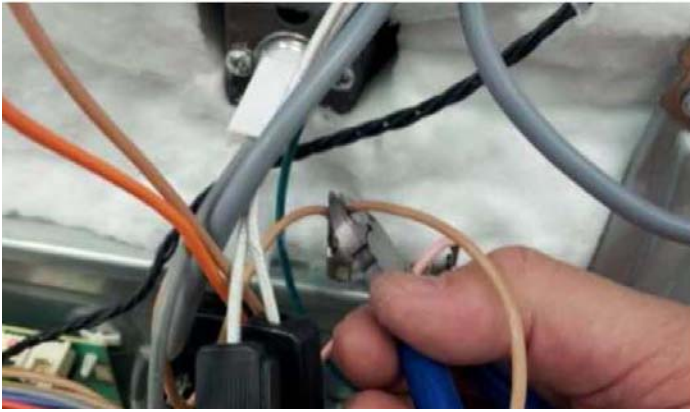
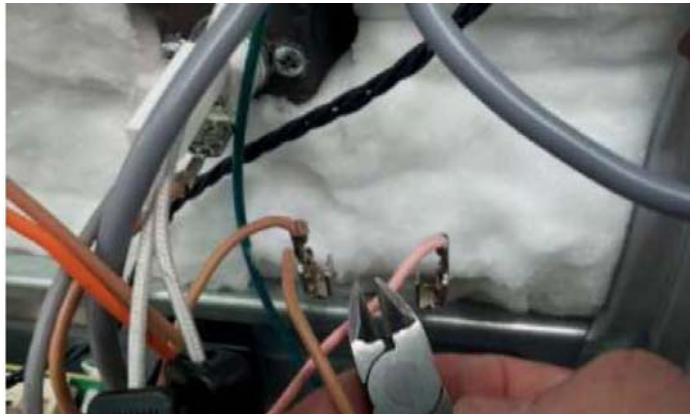
3. Cut the other end of the loose brown wire as close as possible to the fan element terminal and discard.

NOTE: Ensure the other wire to the double terminal is left intact – this is needed to power all elements.

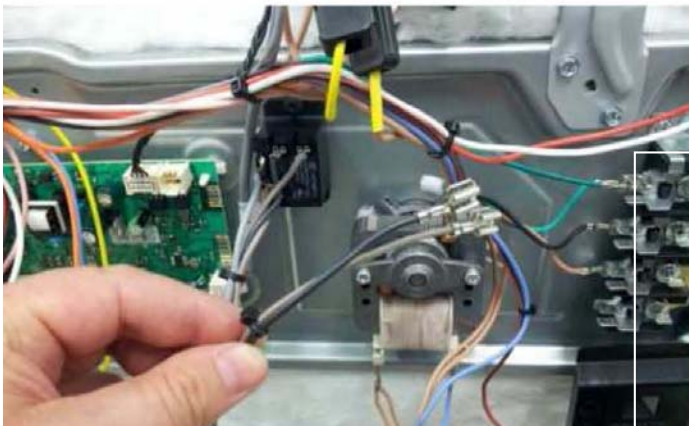
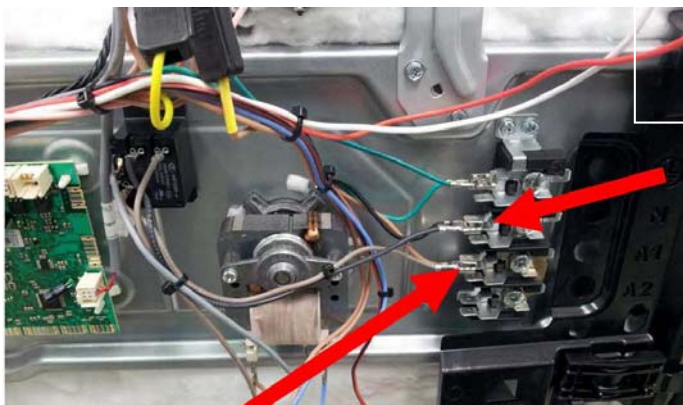
4. Locate the Brown and Black wires (two wires cable tied together) and connect to the terminal block.

A1 - Brown
N - Black

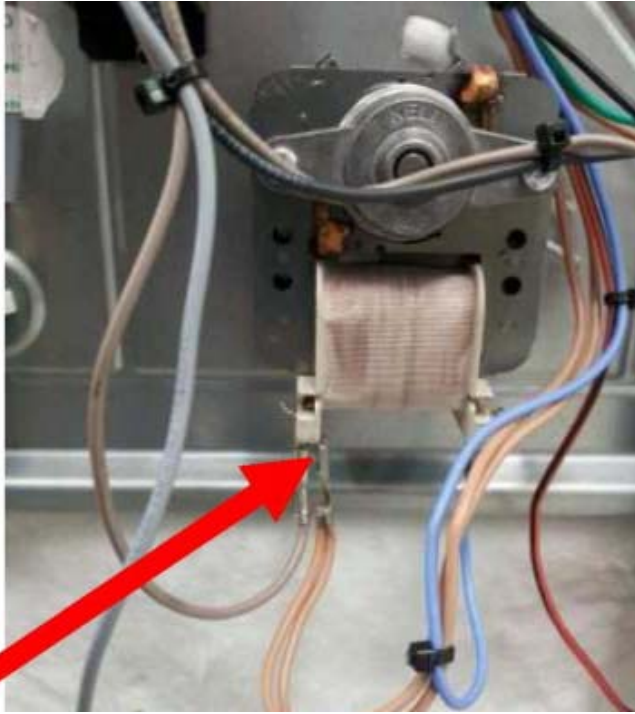
5. Connect the other Brown wire Double Piggy back terminal to the Brown of the fan motor.

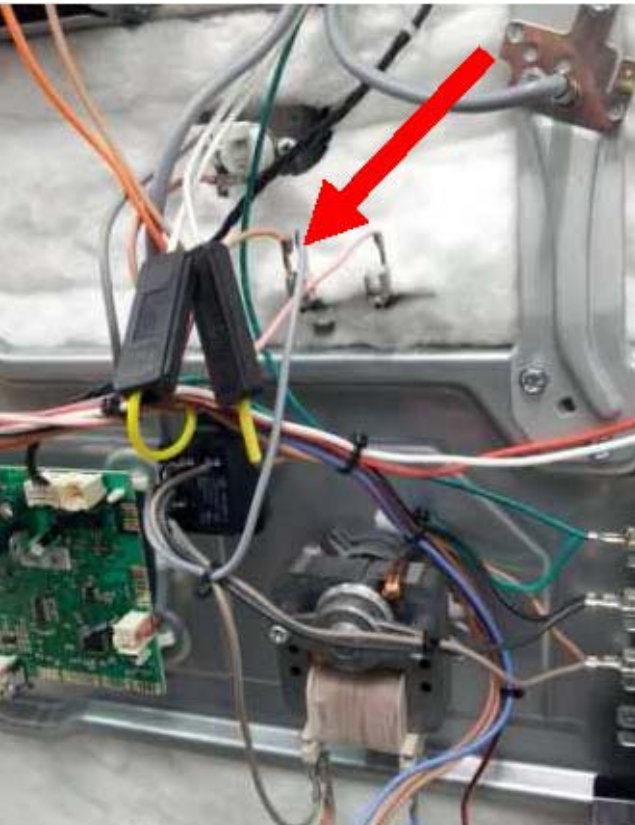
6. Connect the single Grey wire to the second terminal on the Fan element (Where the original brown wire was cut from in Step 3).

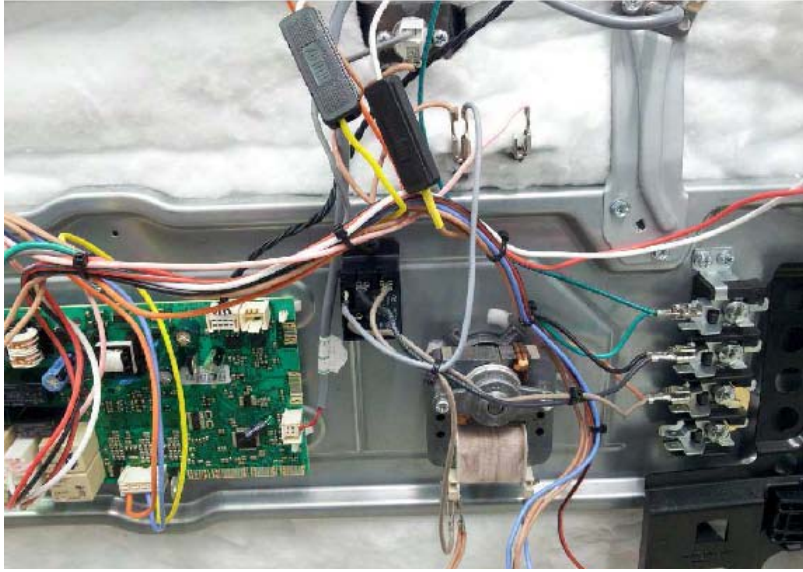
Assembled harness and relay.

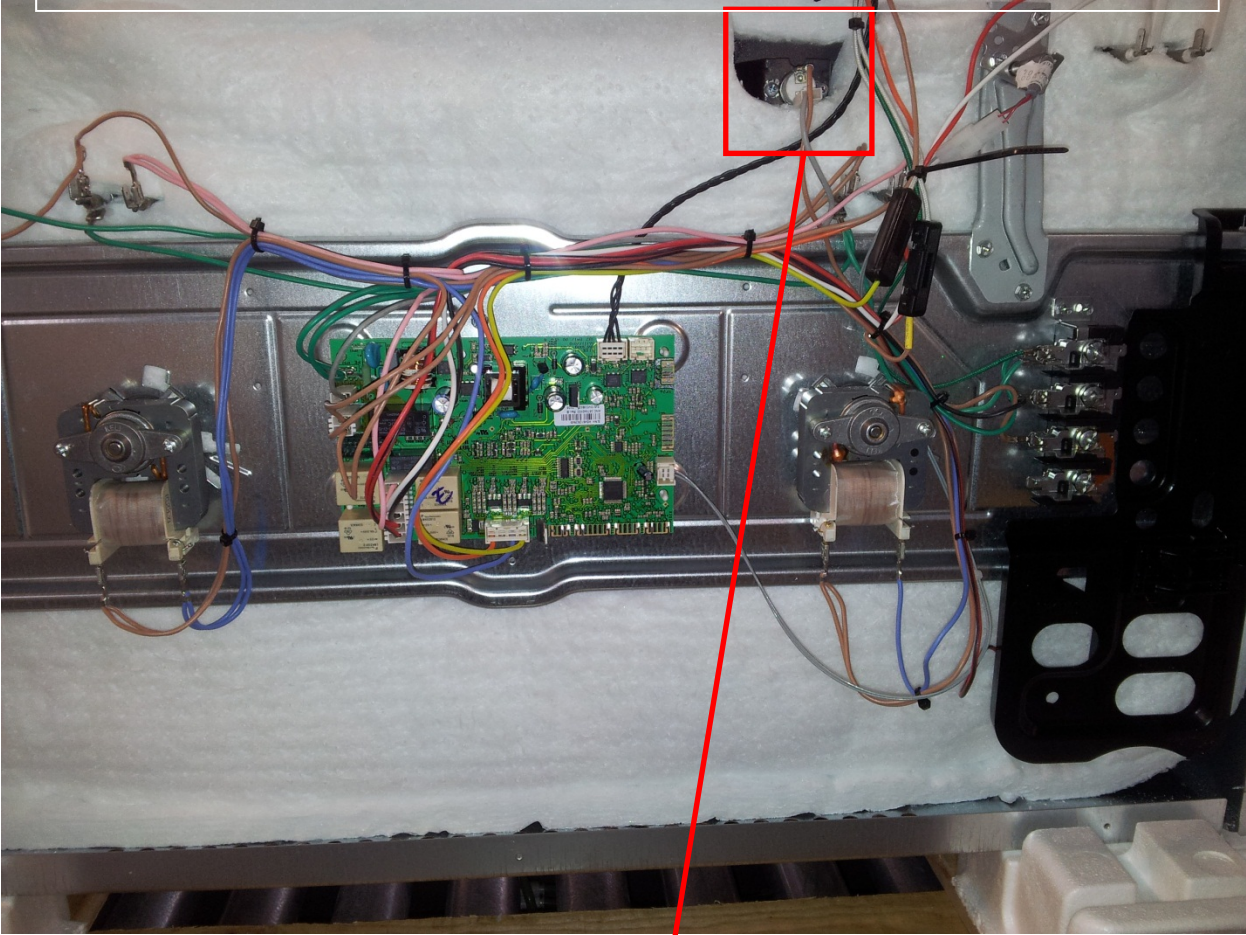
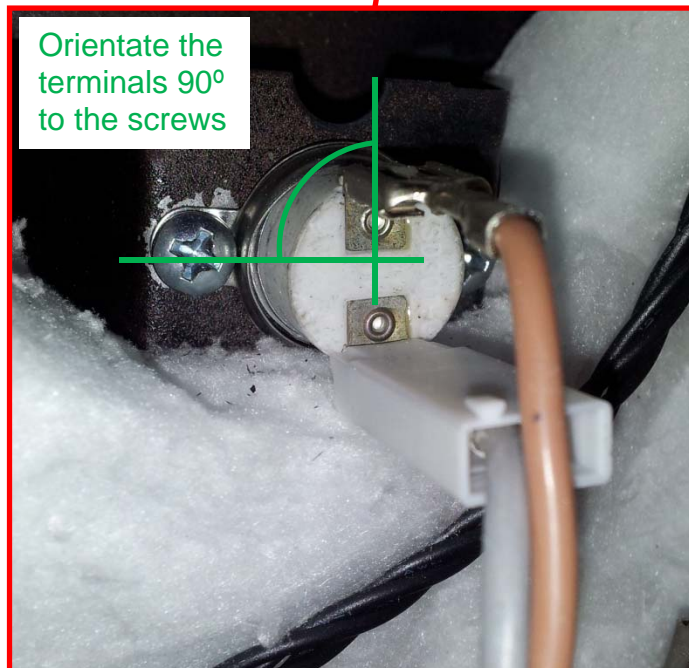
Klixon installation

Ensure the Klixon is fitted in the correct orientation as shown in the pictures.
