### ICE FORMATION IN COMBI TOP FREEZER COMPARTMENT

Ice formation in the middle of the freezer compartment of combi top appliances.

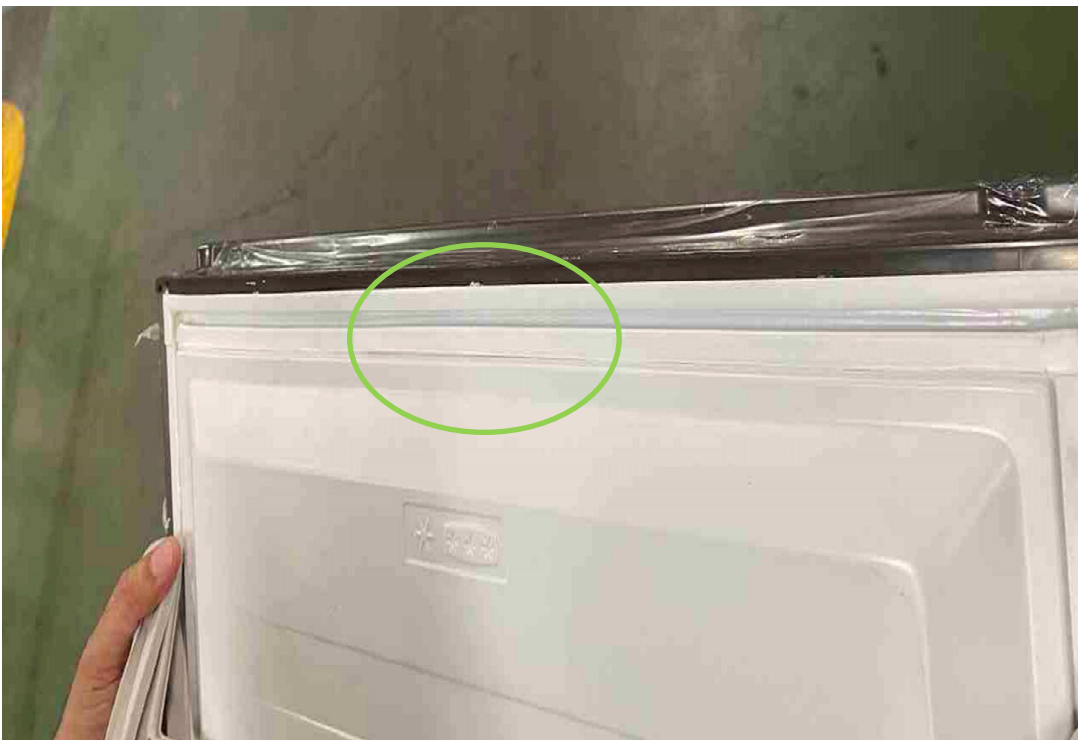
#### Image 1

Before replacing the door, make sure that the new spare part door has the new design with a straight door channel (image 1)

Replace the freezer door according to the spare part list below.

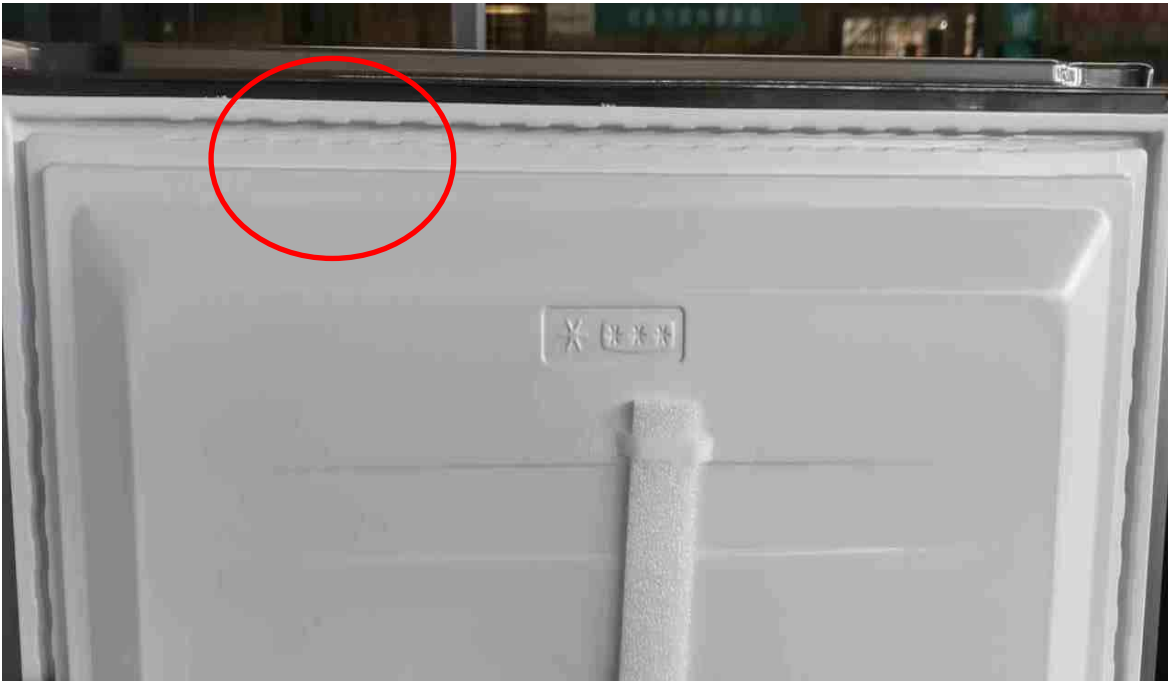
**Image 2**

Old design, replace this type of door.
