GAS SPRING BROKEN IN COOKER HOODS

DESCRIPTION:

Cooker Hood gas spring in area of glass is broken or not working smoothly.

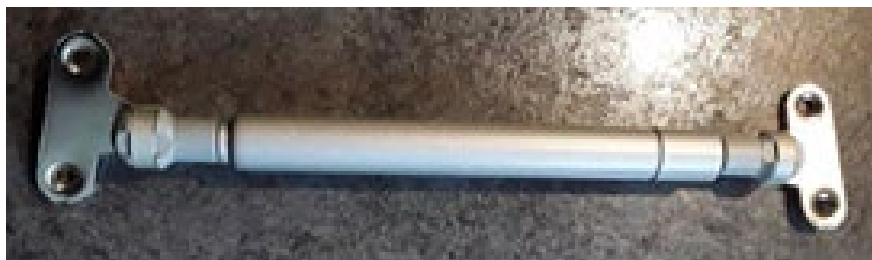
2 01 19-98 / 8 - Spring, gas, grey.

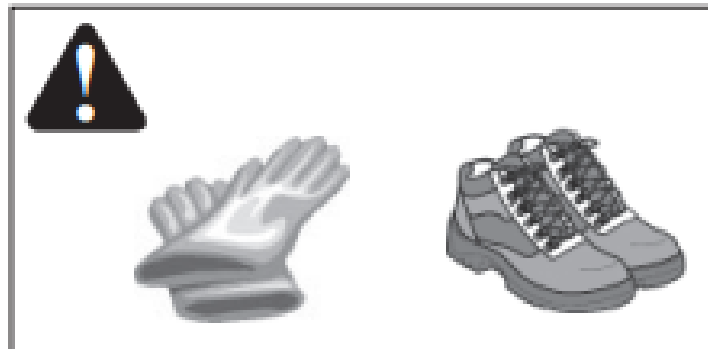
It is mandatory to wear anti-cut gloves and safety shoes.

It is highly recommended to provide gas spring exchange in two people – **IN EACH CASE GLASS MUST BE PROTECTED AGAINST FALLING.**

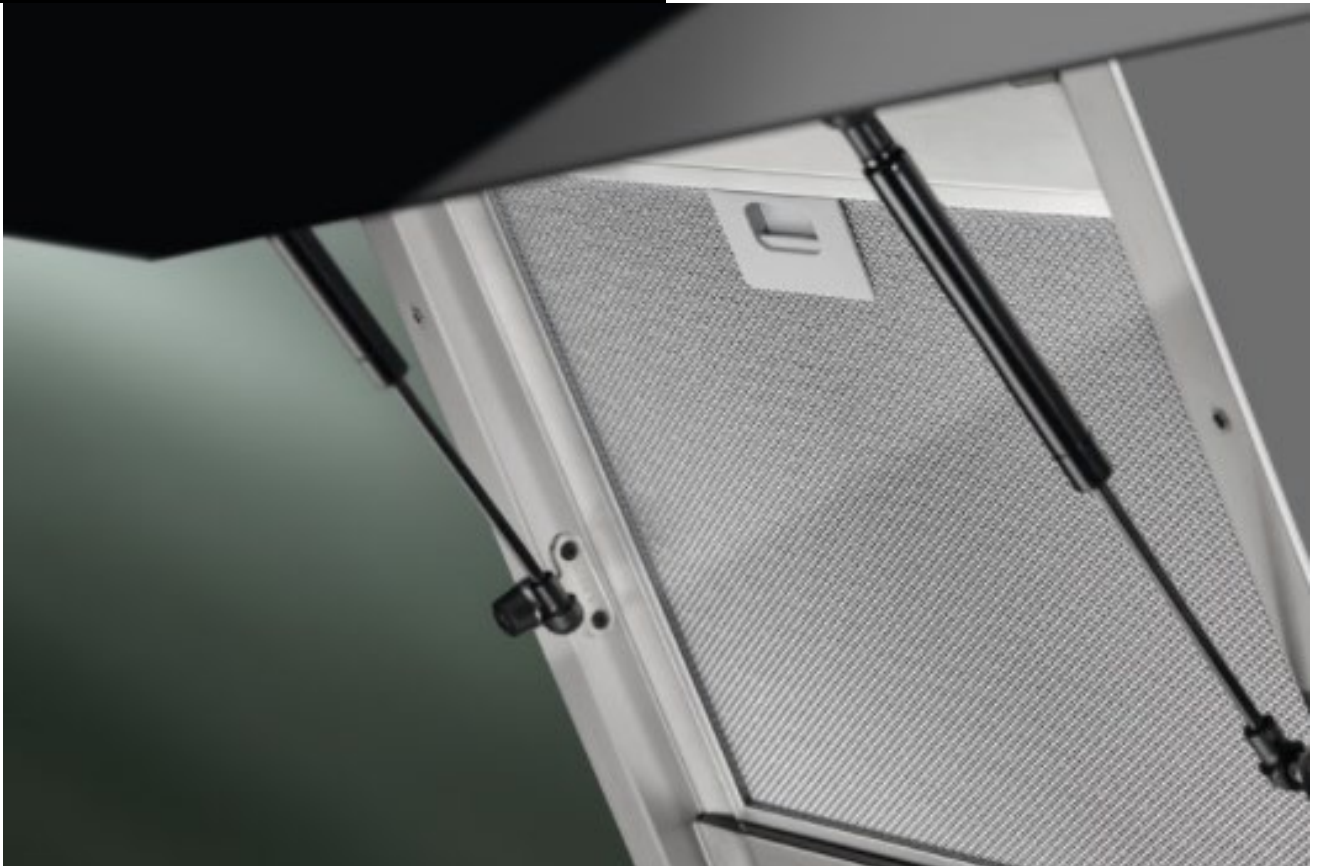
1. Open unit – Pull up glass. **MAKE SURE GLASS WILL NOT FALL DOWN. GLASS MUST STAY OPEN AND PROTECTED UP TO THE END OF REPAIR PROCESS.**

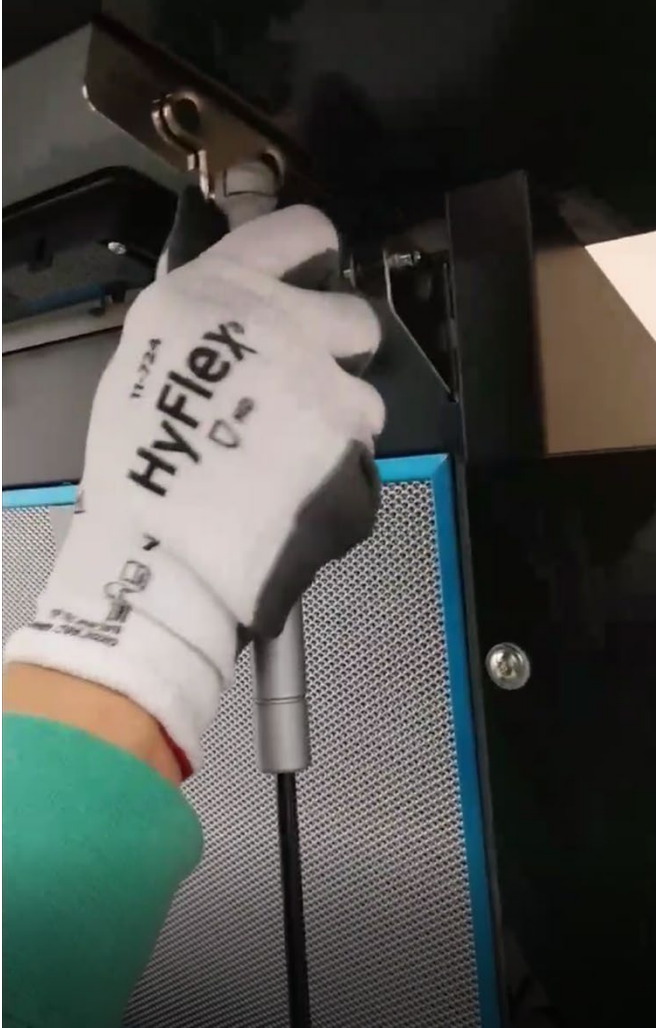
4. Apply and tighten the new spring starting from the top of the hood. Then repeat the operation at the bottom of the hood.
