## Prevent Water leaking out of the valve

### DESCRIPTION:

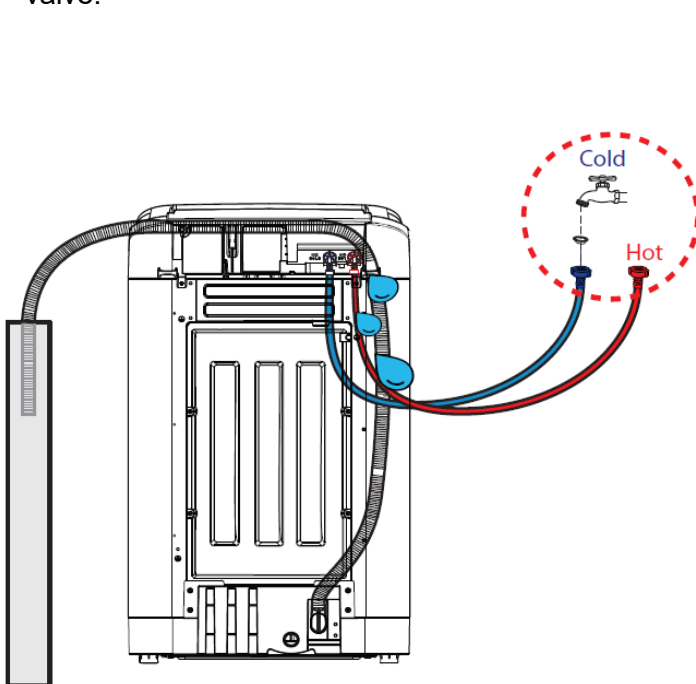
Fig.1 Not remove the hot water inlet hose

This belongs to the Top load washing machine with a HOT & Cold water inlet valve. If only have a cold water tap; when installing the water inlet hose, you not remove the hot water inlet hose from the washing machine (Fig.1) and not fit a blank cap to HOT water inlet valve (Fig.2). The water may leak out of the valve.

1. To fix the issue in the field, Remove the hot water inlet hose with the RED ends from the washing machine and fit a blank cap (with a sealing washer) to the HOT water inlet valve as shown in Fig.
