LEAKAGE ON THE BOTTOM DUE TO THE BROKEN INLET VALVE HOSE

Due to the clogged water distributor inlet valve hose can be damaged.

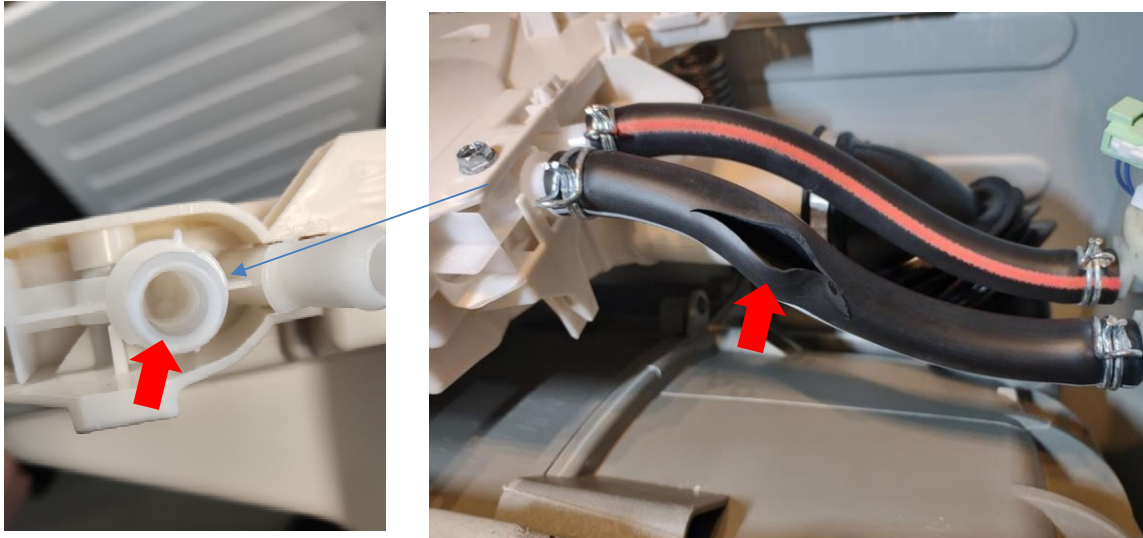
On the picture below you can find example of broken inlet valve pipe and clogged water distributor.

Clogged water distributor channel and cracked inlet valve pipe.

In such case, please exchange related to PNC inlet hose pipe and water distributor:
