SERVICE BULLETIN

NEW RUBBER GASKET

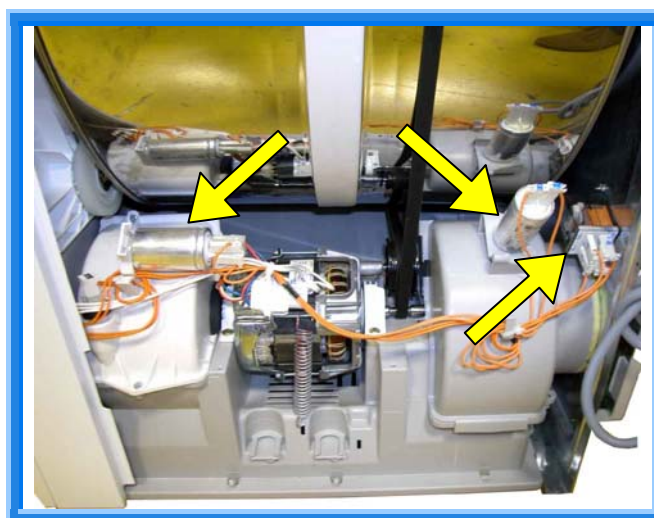
Before modification

It has been discovered in the laboratories of the Siewierz factory (Poland) that in some dryers, after working hours in extreme conditions, on the motor shaft, which activates the front fan (hot air circulation) there was excessive humidity and cloth fibres came out from the front scroll. To avoid any possible malfunctioning a new basket has been introduced between the motor shaft and the front scroll cover.

Should similar problems arise on the above mentioned appliances without the gasket, it is advisable to remove the front scroll and to insert the gasket part no. **125 64 26 00-6** between the motor shaft and the scroll, as shown in figure and inform the Electrolux service department about the problem (error code 03).
