**ICING IN MULTIFLOW COVER PREVENTION
466 COMBI NO FROST PRODUCTS****DESCRIPTION:**

PNC/MODEL:

PNC	Model
925993134	EN4084JOX
925993136	S74010CMX2
925993144	S74011CMX2

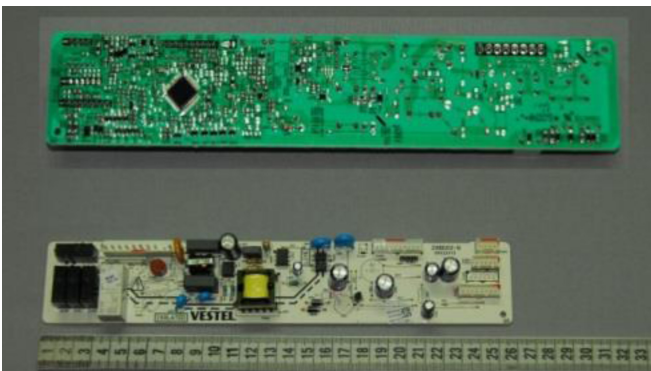
NEW PCB:

Only serial numbers before 546xxxx are affected by cold module ice built issue.
PCB with new software was implemented in production on week 46 2015.

4055368718- Main electronic board

CAUTION: The Plug must be pulled out before the mainboard group is assembled!
