**PROBLEM WITH INEFFICIENT SPIN CYCLE IN FRONT LOADED WASHING MACHINE WITH EWX14
MAINBOARD AND EMC14 MOTOR CONTROL BOARD**

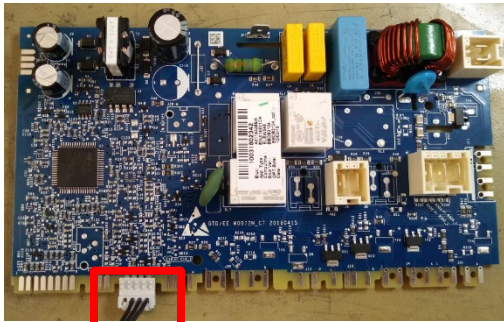
PCB EWX14

After the washing cycle, user notices that clothes are still wet (insufficiently centrifuged). In some cases alarm 'EF5' may be stored in electronic board memory

2 Order and replace below parts (only if [step 1](#) did not solve the issue)

140112864065 or 3792689303	Inverter,electronic board,assembly,EMC18EVO,800W,CIM
140122353018	Harness,motor control,main electronic board,1170mm

2a Reprogram PCB from previous ELC EMC14 to **ELC EMC18** (see [Table 1](#) in attachment)
