Service Bulletin

Concerning: Compact Steam Combi and Classic from Schwanden

Problem : Milky condensation on the interior door plates

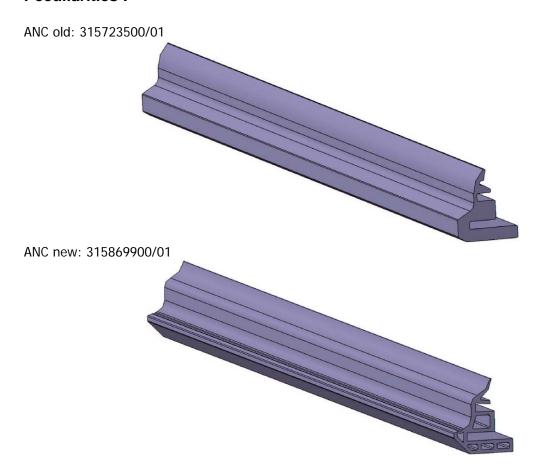
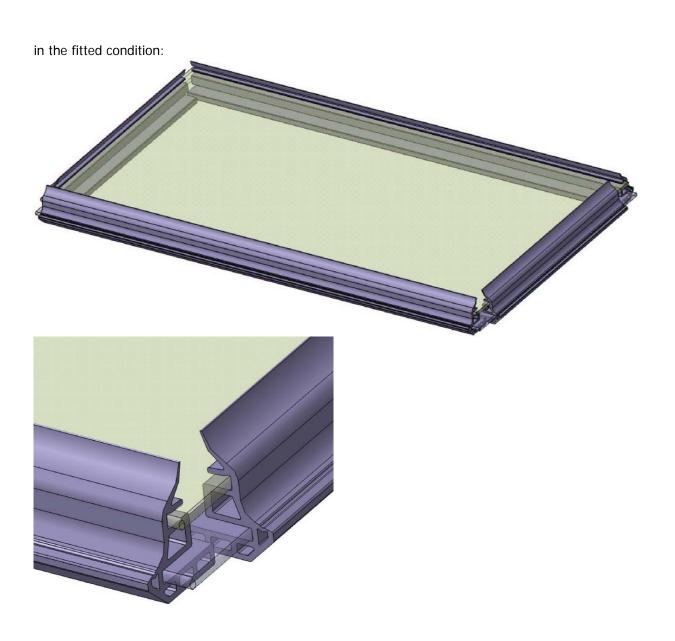
Cause: Exhalation of silicone material creates a milky white condensation on

the interior plates.

Affected components:

New glass retainer spare parts test 315 6926 03

Solution: After cleaning the interior plates, the glass retaining profile must be

replaced with the spare parts set 315 69260 03 in order to avoid the

continued exhalation of the old glass retaining profile.
