Service-Bulletin

Washing machines

599 709 103 EN

1. Noises with drain pump (ASKOLL)

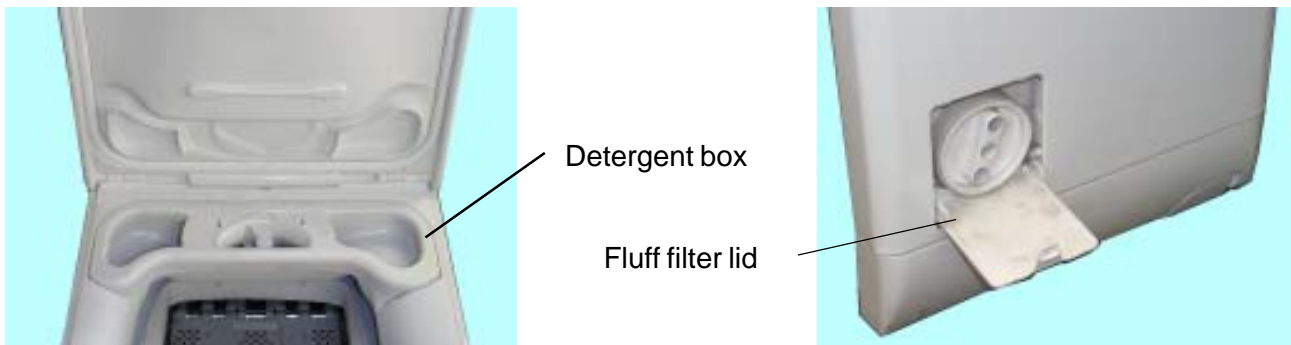
Concerned are all appliances of the series CLAUDIA.

Distinguishing mark: Water inlet compartment in the upper part and fluff filter flap in the front panel.

- Cause:
- a) Vibration noise with the pump housing
 - b) Operation noise within the bearing area.

- Measure:
- a) Secure the pump casing with silicone, or clamp a foam part below the pump housing.
 - b) Replace the drain pump.
 - Ref. 146057320/5 drain pump PLASET
 - Ref. 407143602/8 drain pump PLASET with silicone

Since week 21/07 (calendar week 44/07 for Germany and Italy) the factory builds in a drain pump from PLASET.
