REMOVING THE EARTHING PIN FROM THE REAR CASING ASSEMBLY

EN Publication number 599 72 70-45	Rev. 00	02/2009	dmm
------------------------------------	---------	---------	-----

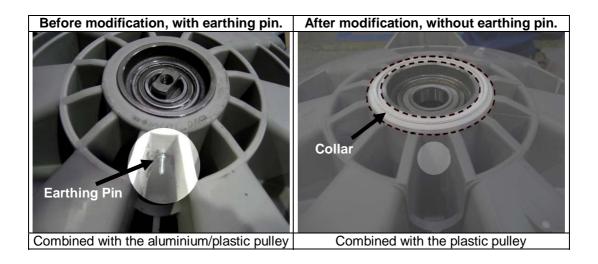
From Serial Number 950 xxxxx in all the rear casing assemblies, a collar has been created in the area around the hub and the earthing pin has been eliminated. As a result of this:

• the relevant wiring is removed and the plastic pulley is used.

PULLEY If the appliance is fitted with the rear casing assembly without earthing pin.

ONLY PLASTIC PULLEYS CAN BE USED

AND USE OF ALUMINIUM PULLEYS IS STRICTLY PROHIBITED.

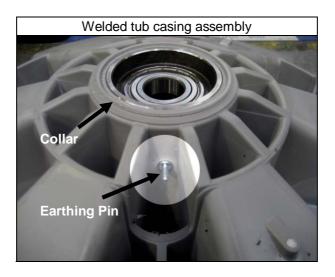
The rear casing assembly, complete with collar and earthing pin, is supplied as a spare part and can be used on all appliances, as shown in the diagram provided on the table in the paragraph "service information".
