**Inability to select programmes on SMART tumble dryers**

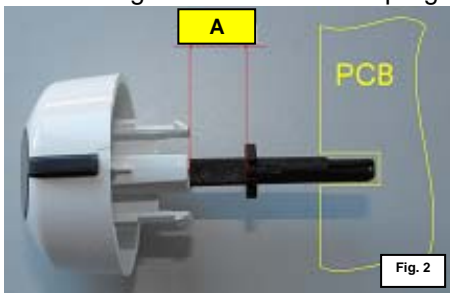
On ventilated tumble dryers featuring SMART styling, which are easily recognised by the typical programme selector knob on the control panel (fig.1), it has been noticed that the pin connecting the knob to the programme selector on the circuit board detaches itself, thereby not allowing the user to select a programme.

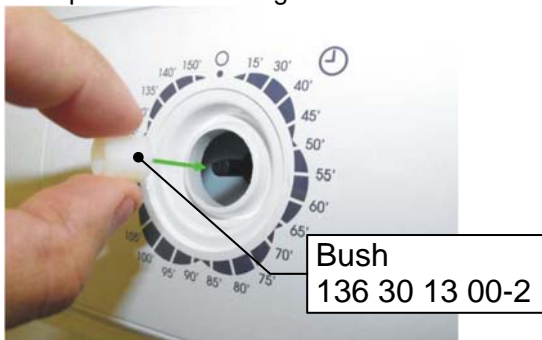
The problem is caused by the excessive distance (A fig 2) between the knob and the retainer ring of the selector pin.

To solve this problem, a bush should be inserted onto the pin connecting the knob to the programme selector, on all appliances - whether affected by this problem or not - as shown in the figure, in order to prevent the pin from becoming detached from the selector on the board.

If it is too difficult to remove the knob, it is advisable not to insist in order to avoid damaging the knob holding clips. Instead, remove the entire board support as specified in the service manual.
