SERVICE BULLETIN

**RM 8400/01/05, 8500/01/05/50/51/55, RMD 8501/05/51/55, RMF 7390L, RML 8550/51/55,
RMS 8400/01/05/60/61/65, RMS 8500/01/05/50/51/55, RMSL 8500/01/05**

Door lock does not open

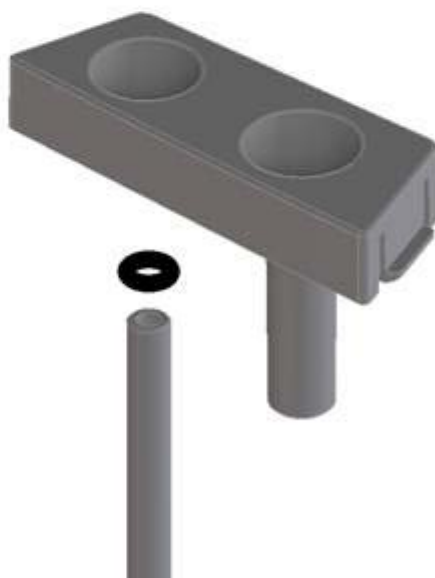
Service kit :
289 0177-00 =>
Model: RM8XXX,RMS8XXX
Door frame black-grey or silver-grey

289 0177-01=>
Model: RM8XXX,RMS8XXX
Door frame lacquered: white-aluminium or champagner

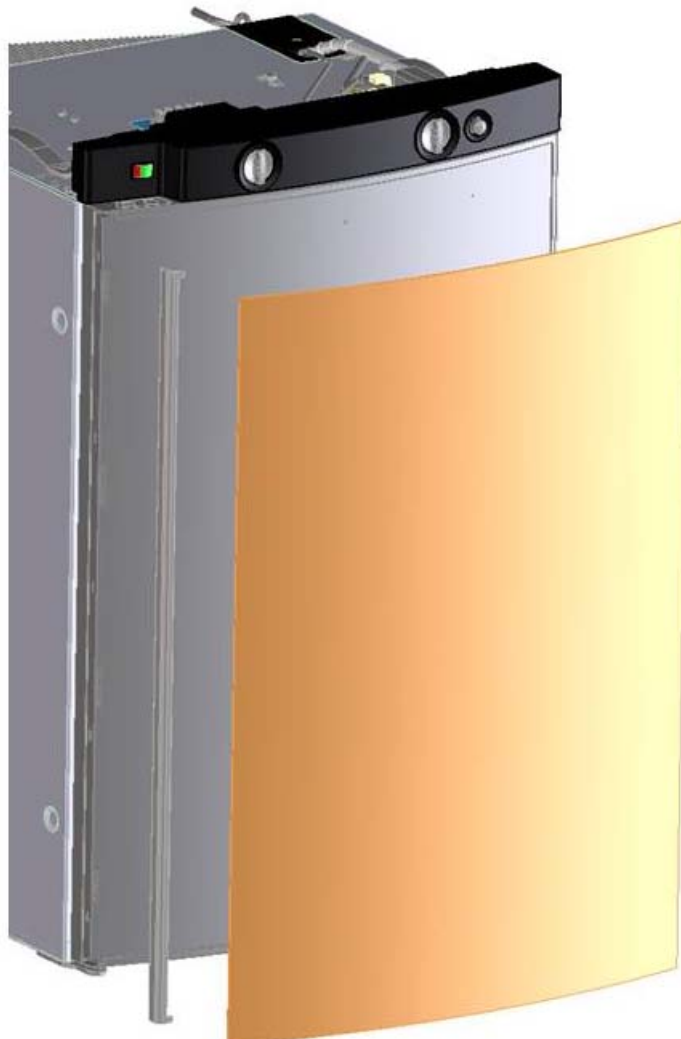
Remove the decor panel

Model RM 8xxx, RMS 8xxx

- Remove the lateral ledge (1) of the door (ledge is attached, not screwed).
- Shift decor panel (2) away from the door.

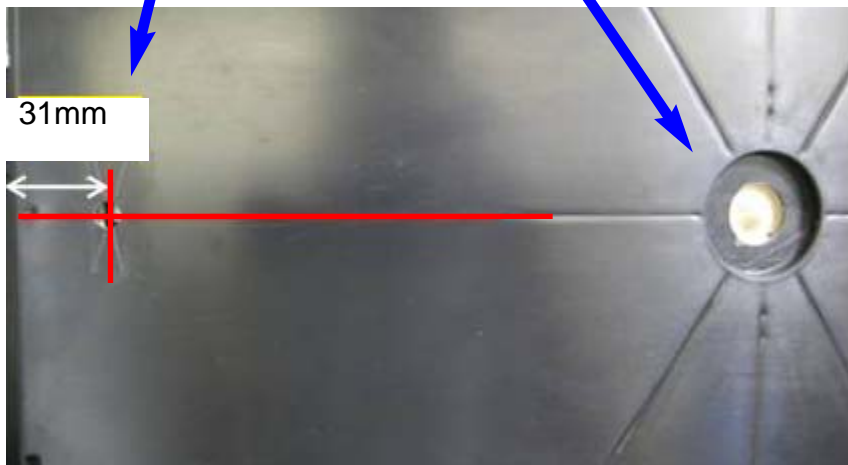
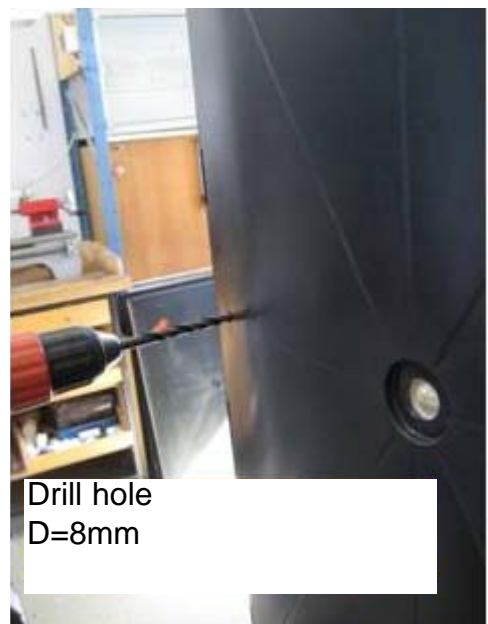
Assign the position of the necessity hole and drill a hole of 8mm.

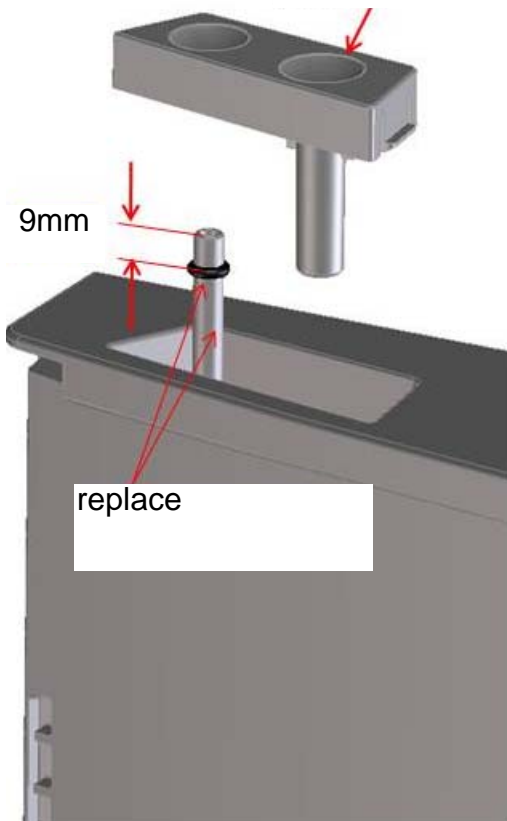
replace (optionally)

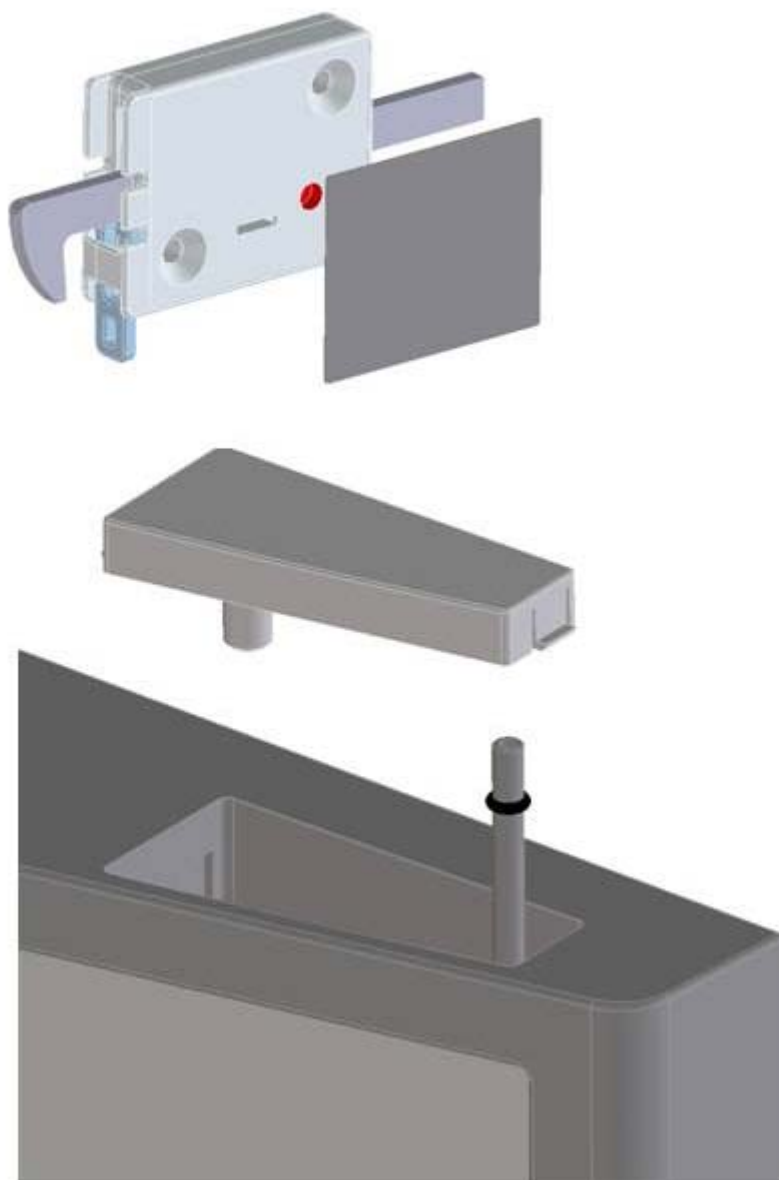
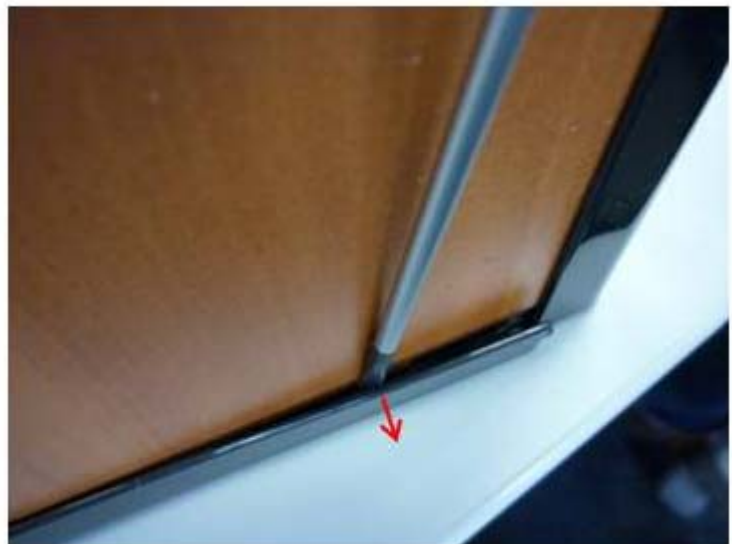
Remove the decor panel

Service kit :
289 0177-02
Model: RMF 7390, RMS 8550 with Fendt door

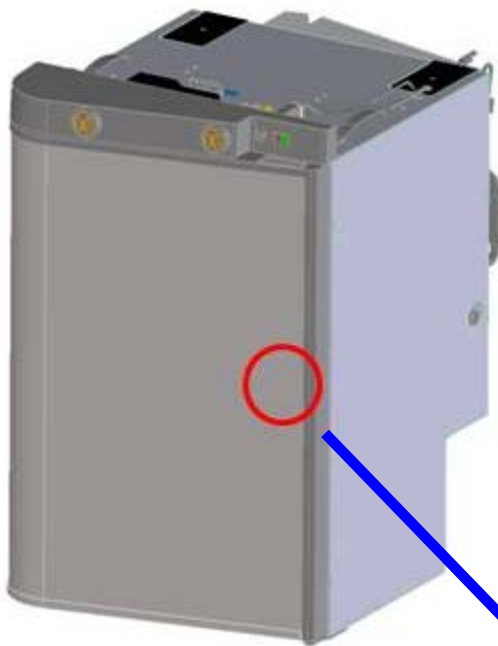
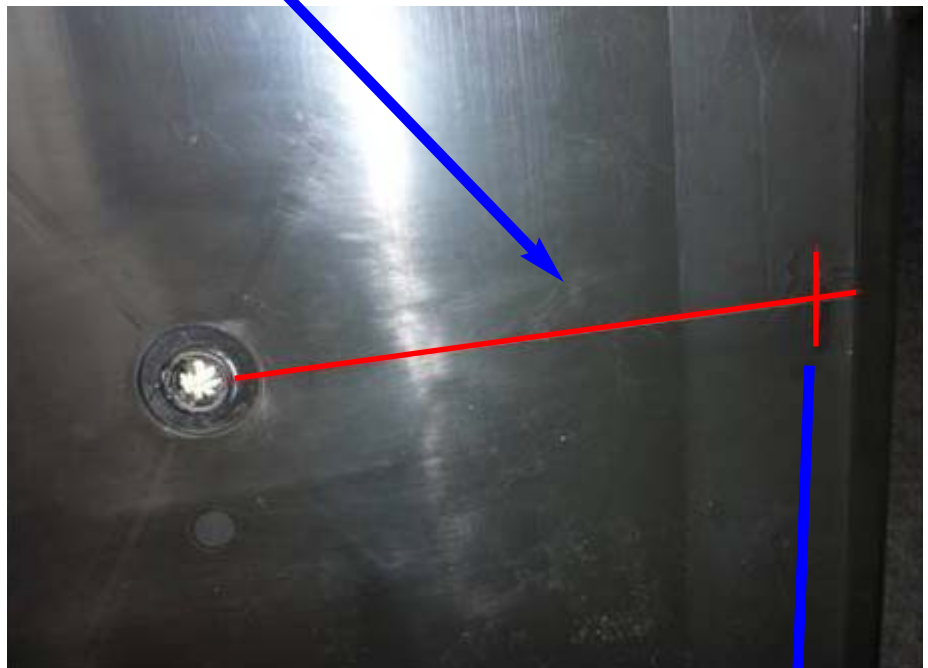
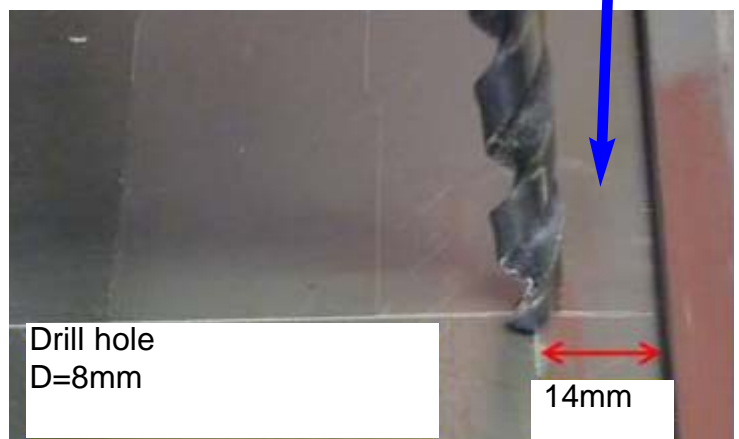
Assign the position of the necessity hole and drill a hole of 8mm.
