SERVICE BULLETIN

RMD 8501, RMD 8505, RMD 8551, RMD 8555, RMDT 8501, RMDT 8505, RMDT 8551, RMDT 8555

Problems with condensation

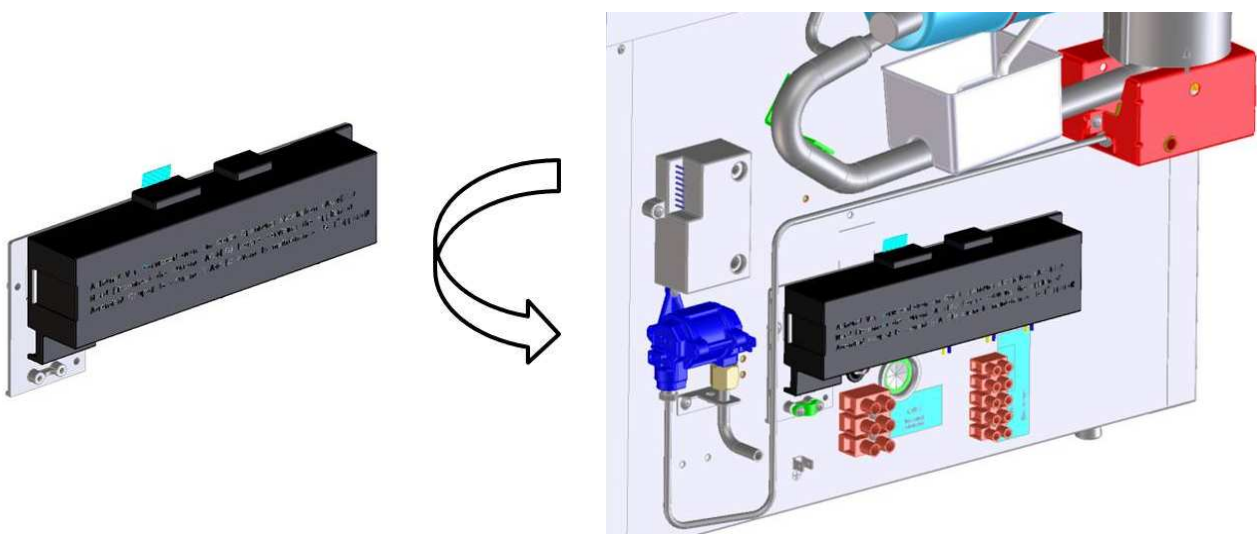
Exchange of the electronics 289 0347-03/8 (MES) or 289 0347-13/7 (AES)

1. Condensation around the operating panel

The electronic is programmed to switch on the frame heating automatically whilst operation on 12V and mains and to allow switching on or off the frame heating manually whilst gas operation.

In case of condensation around the operating panel please install the following service kits:

289 0347-02/0, RMD/T 85x1
289 0347-12/9, RMD/T 85x5

These service kits comprise the new electronics 289 0347-03/8 for MES or 289 0347-13/7 for AES (frame heating is not switched off automatically after two hours), an insulating seal for the freezer compartment door 293 5688-21/4 and an instruction 210 6513-54/8.

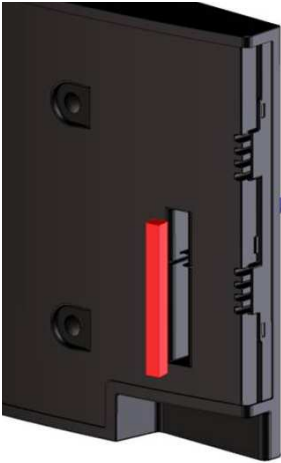
2. Condensation on the freezer compartment door around the lock

Mounting the insulating foam strip 293 5688-21/4.
Please read the service bulletin 599 7471-57.

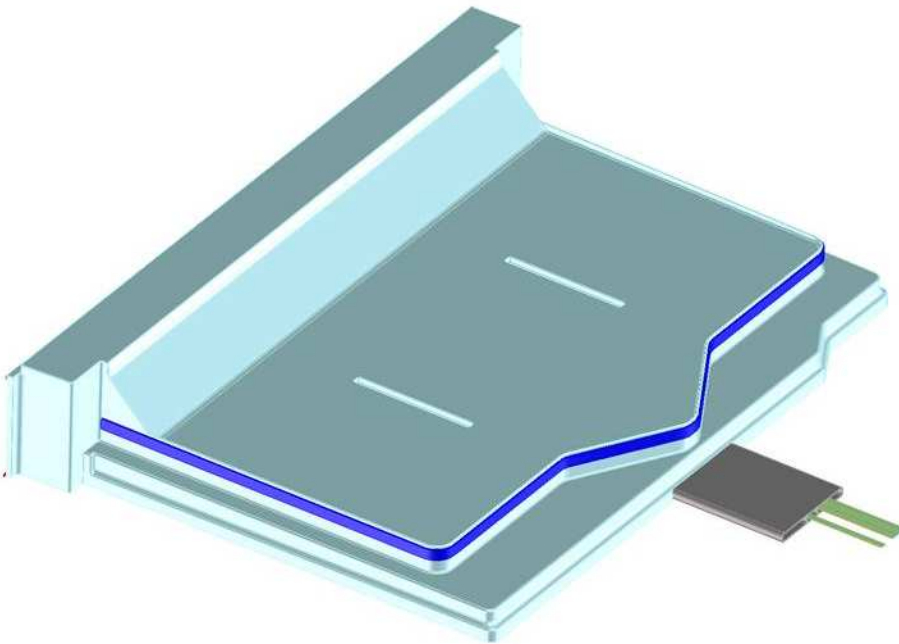
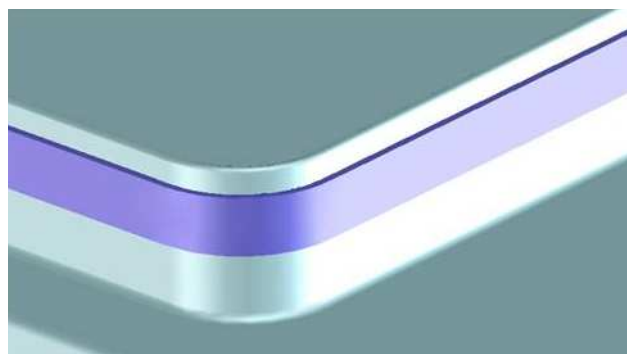
3. Condensation in the inner liner and icing-up of the evaporator in the freezer compartment

In case of condensation spreading from the freezer compartment to the inner liner via the freezer compartment bottom please install the seal 295 1227-31/9.
