Washing Group Replacement

Welded washing group **1268576418** is no longer available; it has been replaced by an assembly kit number **4055173779**

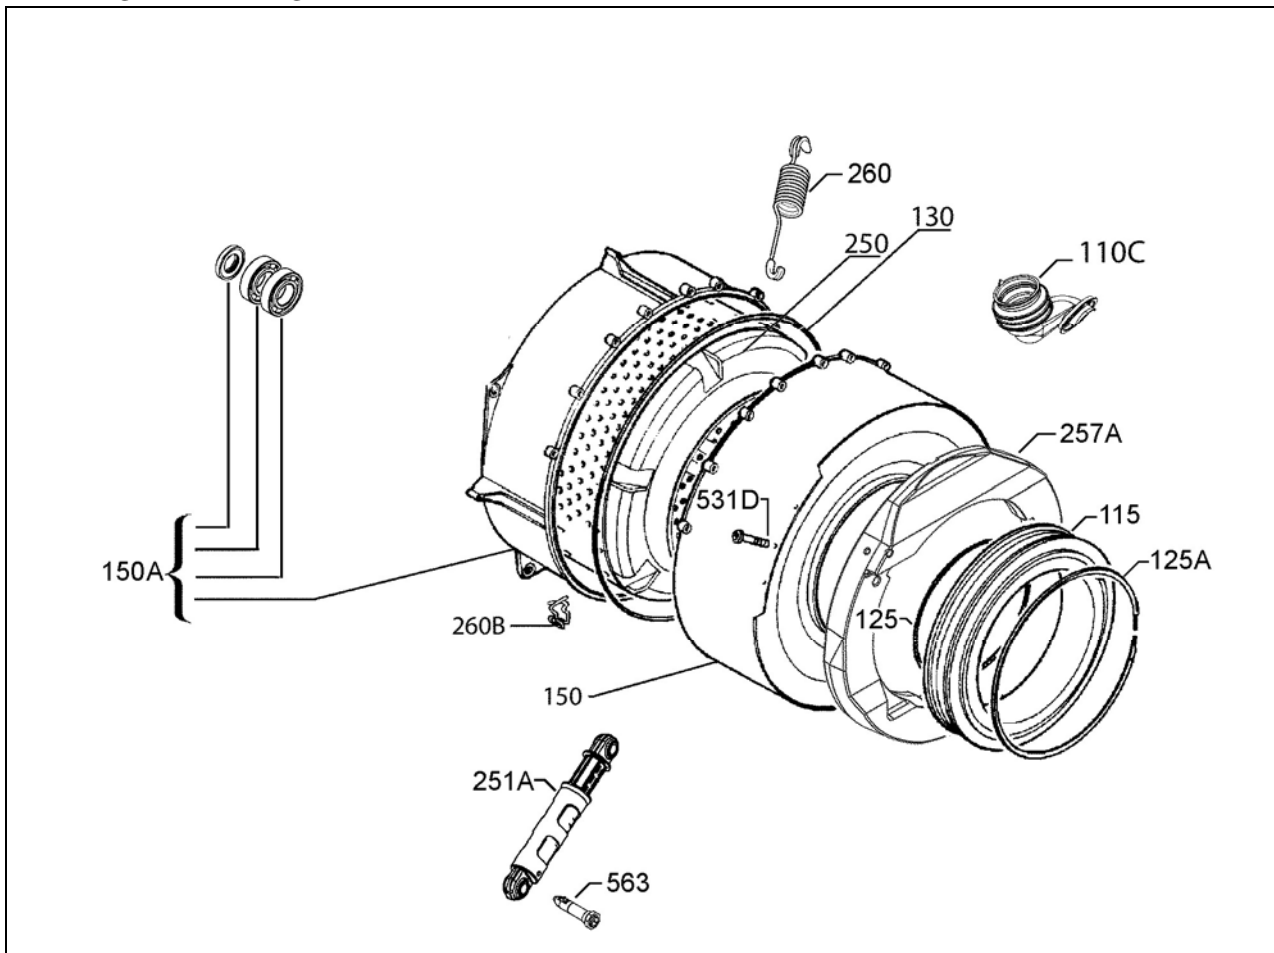
SPARE PARTS:

In case of exchange, the following components need to be replaced:

Kit 4055173779 contains of:

Position	Spare part description	Spare part number	Quantity
110C	Hose bend, water inlet compartment	110872200	1
115	Rubber bellow, porthole	13200410	1
125	Fixing spring, rubber bellow, tub	13200240	1
130	Gasket, shell, tub	12401590	1
150	Shell, front, tub, G20/G21	124965747	1
150A	Assembly, shell, back	132683270	1
250	Drum assembly G20 1200/1350 R"	132651900	1
251A	Shock absorber	132255301	2
257A	Front counterweight.13.5KG GREEN	110847950	1
260	MUELL.SUS.GRUPO (G19-G20)	126063351	2
260B	Heating element spring	124782510	1
125A	Glass, porthole	132224500	1
531B	Screw, shell, tub	132229010	17
531D	Counterweight screw 8X47	132658901	5
563	Bolt, cushion	126053400	4
