## KASAI WM – LOOSE TUB SPRING

### MODEL REFERS TO:

WM FL KASAI 914908xxx with serial number from 214xxxxxxx until 250xxxxxxx

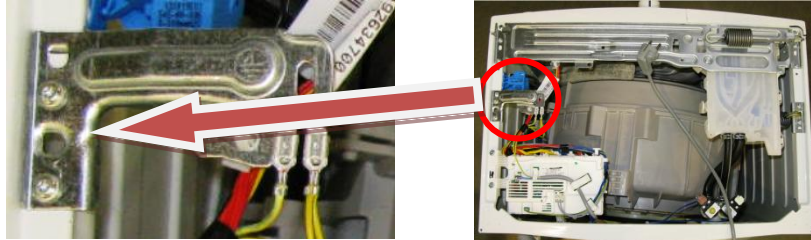
In case of improper load balancing in front loader Washing Machine under specific conditions spring may jump out of outer case support. Pic.1. show WM where spring jumped out

Pic.1. WM example of spring jumped out

In cases where product exchange is no needed, service kit 4055212114 with two springs lock (for left and right side) should be used.

Spring lock – kit number: 4055212114

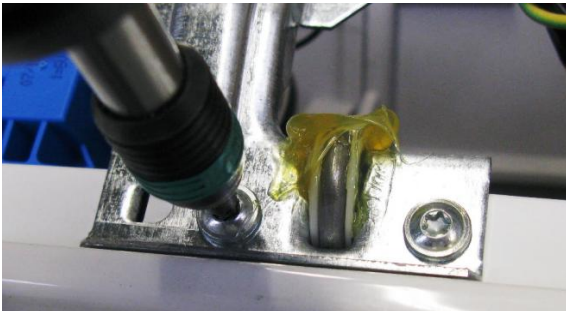
Pic.2. Loose screws in any order.

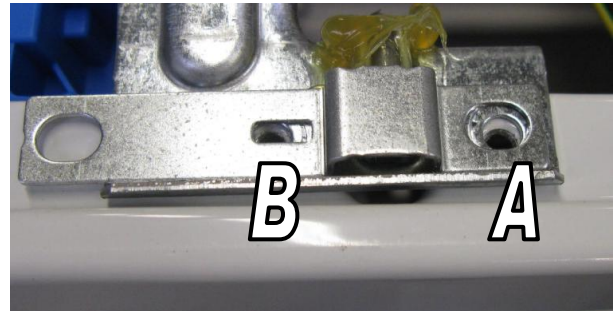
Pic.3. Position spring lock in such way as it is shown on the picture above.

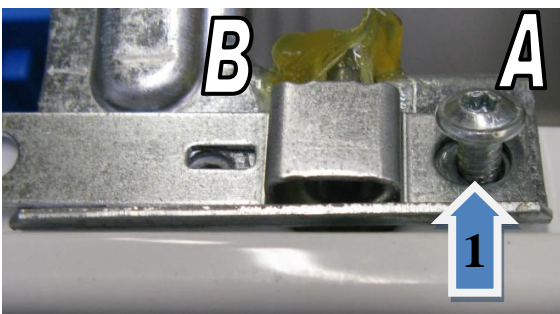
Pic.4. Using the same screws tighten screw in hole A and keep position of spring lock to have possibility to tighten screw in hole B.

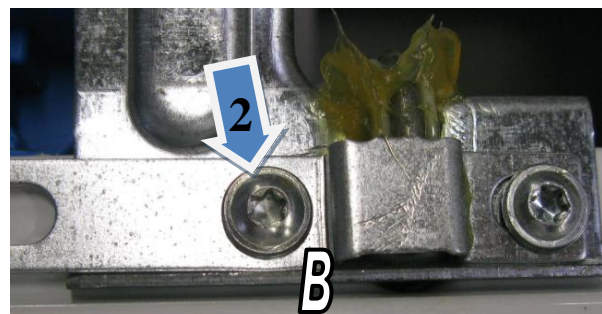
Pic.5. Tighten screw in hole B.
