### TOP DOOR OVEN COVER MELTED ON PYRO OVENS

When the pyrolytic ovens Apollo cover door is melted, it may be due to one of the following three reasons mentioned below:

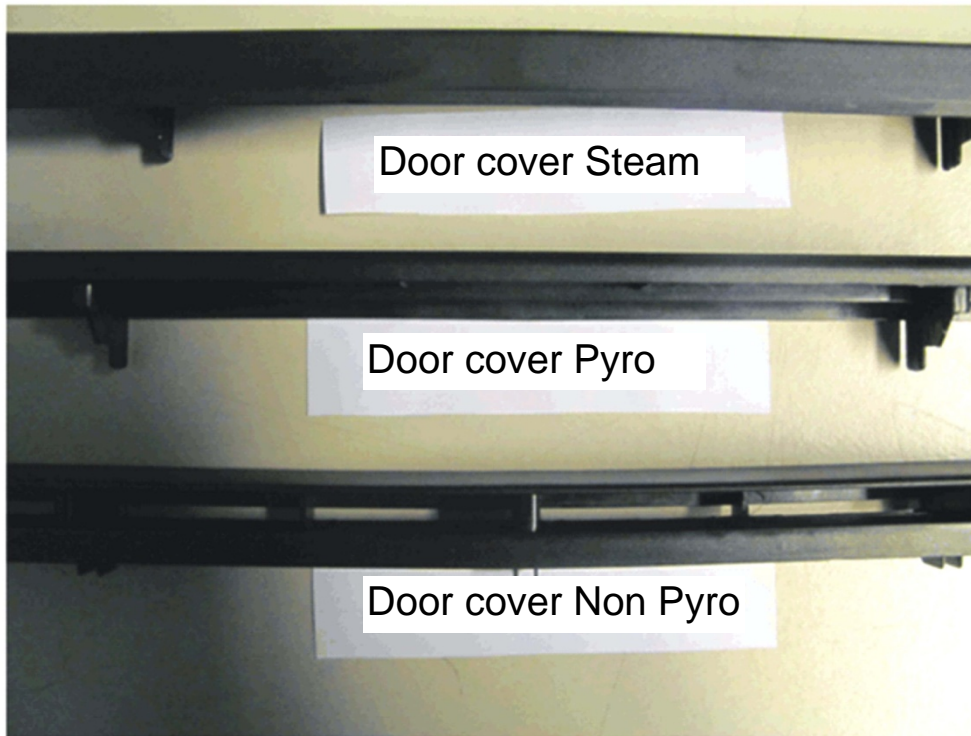
Fig. 1

1. It was a wrong Door cover (non-pyro Door cover) in the factory installed. The Technician can see this from the following pictures, or at the part numbers on the Door cover.

Here are the pictures of the various Door covers.
