Positioning of protection foil on OVC3000 boards in microwave appliances

This service bulletin is related to all compact microwave appliances with OVC3000 power board.

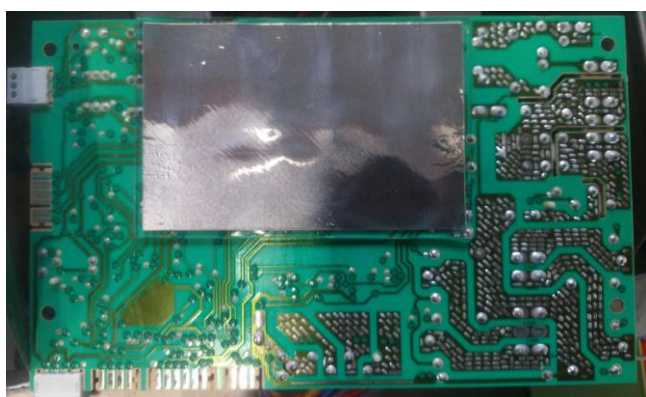
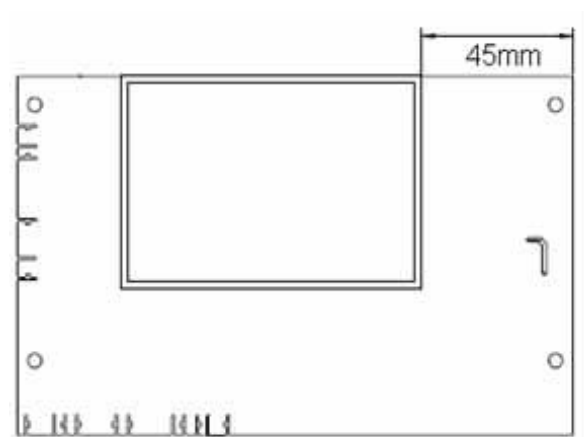
Residual microwave radiation may cause malfunction of OVC3000 power boards.

Foil should be placed on the bottom side of the board, 45mm from the edge, as seen on pictures above

To prevent this, factories have implemented additional protection foil to insulate vital components on the power board. The foil is available as separate spare part 5550593023, and should be used in all cases of OVC3000 replacement in microwave appliances.
