Exchange of control panel brackets with new ones

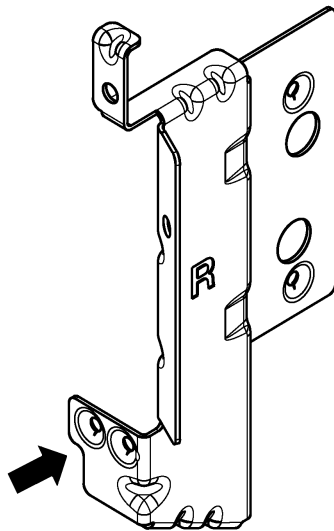
Old bracket

In ovens, construction of control panel brackets has been modified. One of the mounting holes has been replaced by a clew. As a result, old type of bracket required two screws to mount the component to the front frame, new type of bracket requires only one screw.

In case of new bracket damage, replace with new bracket. In case of old bracket damage, both possibilities can be fitted correctly.
