'18' on Kite or '3 67' on Falcon pulsing on display

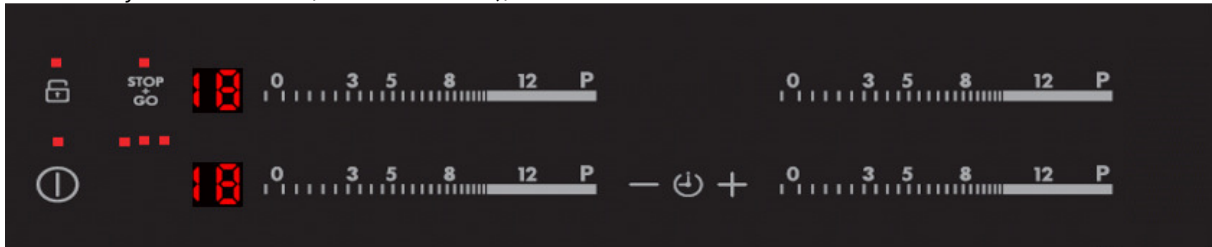
Induction hob controlled by Kite user interface shows a pulsing '18' on both left zones (approximately 5 seconds on, 5 seconds off),

1. Change the induction board that has a jumper on it,
2. No user interface replacement is necessary
3. Report in QES as 851 Induction module / unit.

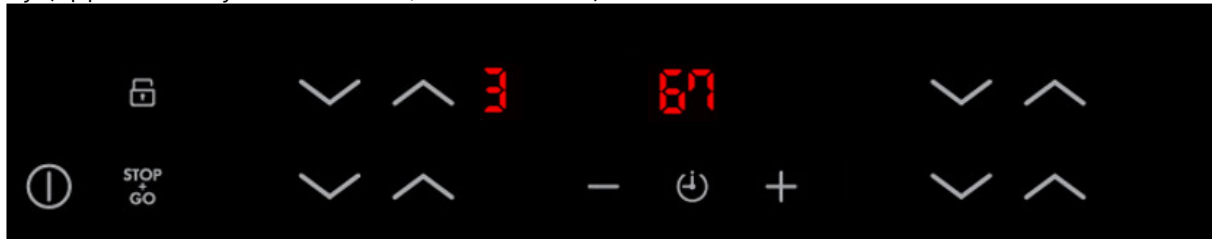
Induction hob controlled by Kite user interface shows a pulsing '3 67' on rear left zone and timer display (approximately 5 seconds on, 5 seconds off)
