SERVICE INSTRUCTION

Multi media device CAM44

Troubleshooting:
Connection of PerfectView
CAM44 to a multi media device

Publication-No.: 599 8102-01 en / Service 2017.02.30 MH

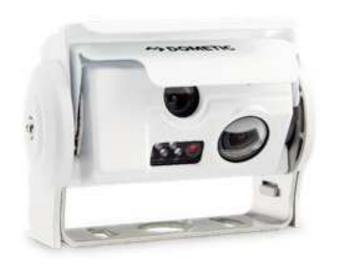
Description PerfectView CAM44

| Pos. no. | Description |
| 1 | 6 pin connection cable |
| 2 | Far-view lens |
| 3 | Infrared light |
| 4 | Close view lens |
| | (Rear view camera) |
| 5 | Microphone |
