### Mounting of new fan cover with the use of fixing brackets

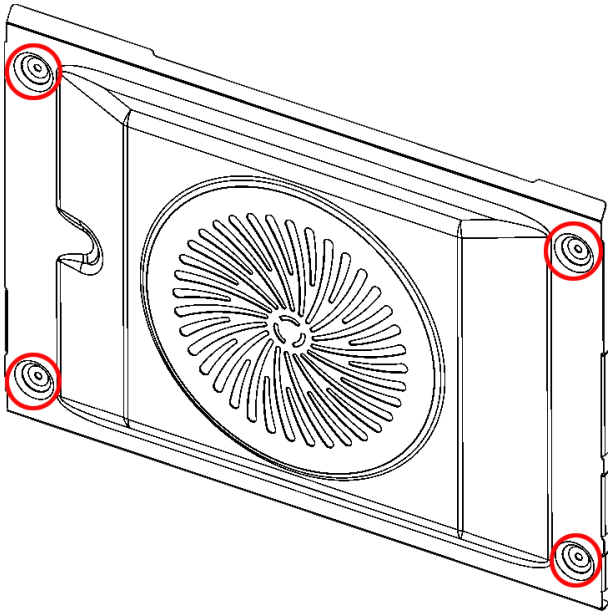
Mounting positions of screws

In non steam ovens, fan cover is mounted by screws which no longer hold to back of cavity. In order to eliminate the problem, it is required to fix fan cover using new screws and fixing brackets additionally.
