OVENS – NOISE & VIBRATIONS DURING THE FUNCTIONING

In case of noise or vibrations during the functioning, it's important to check the top cover.

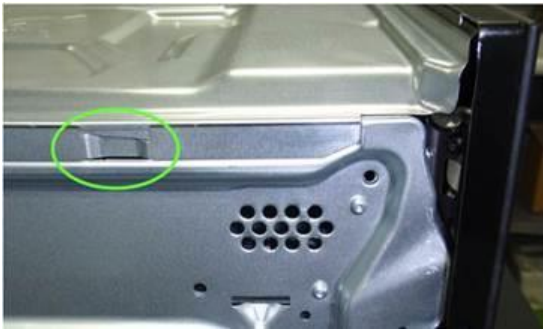
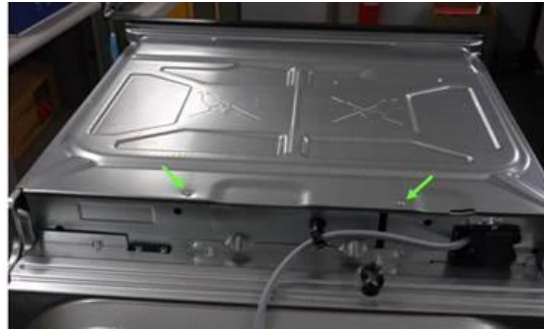
- To verify that the top cover is properly snapped-in at the front (green circle) and fixed by means of two screws at the back (green arrows)

- If the noise remains, to replace the top cover ordering the spare part number 140064666039
- After the replacement of the top cover, if the noise remains, to check the cooling fan assembly
